Pole Fell from Hiab During Removal (LL265)

Incident		Description
Event Date: 15/11/2024	Time: 16:00 hours	Location: Arapuni – Hamilton - A0263
NP Reference / External Reference: OCC14661/INV1691 Maximo Incident 176448

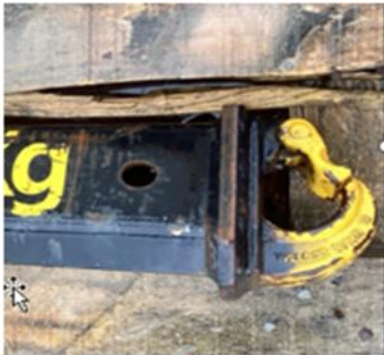
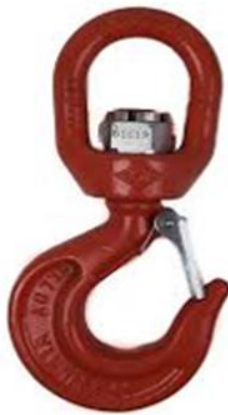
While the excavator and Hiab worked in tandem, with the excavator pulling the base backward and the Hiab lowering the top, the sling unexpectedly released from the Hiab's hook causing the pole to fall approximately 4 meters to the ground.

The contractor used a fixed hook for lifting the pole, which provided clearance to protect hydraulic hoses but introduced a risk of the strop rolling out. A 5-ton synthetic sling was used, exceeding the 1-ton load, but synthetic slings are not ideal for lifting wooden poles due to the risk of slipping or tearing on sharp edges. Steel chains are recommended as the safer alternative.

Northpower's pole replacement procedure lacks clear guidelines on sling selection, conflicting with best practices that favour steel chains. Additionally, wet conditions increased the likelihood of the synthetic sling slipping on the wooden pole surface.

Human factors contributed to the incident. The sling may not have been fully engaged in the hook, leading to partial engagement and potential release. Poor communication between the Hiab and excavator operators further heightened the risk of roll-out. Finally, the Hiab operator did not visually confirm the sling's security before or during the lift.

- Fixed lifting hooks are **not** to be used when installing or removing poles.
- Steel chains are to be used for all wooden pole removals.
- Ensure clear communication protocols are established and followed between Hiab and Excavator operators.
- Visual check of the security of loads are to be made before and during the lifts.
- This event highlights the importance of implementing and maintaining an exclusion/drop zone where the risk of falling objects is identified.
- Northpower to review and update procedure to remove potential use of slings when removing wooden poles.
