Event Number: 157732

Event Classification: Network Near Miss

WHAT HAPPENED

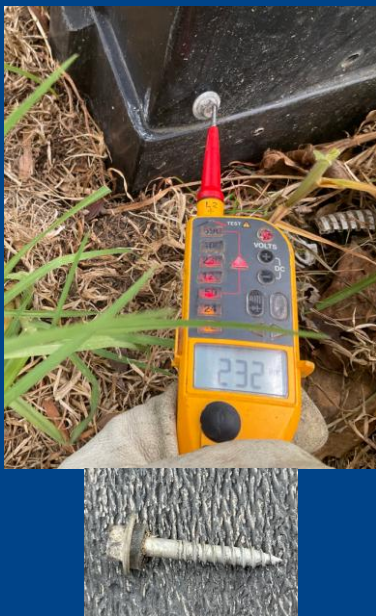
Whilst investigating a no power a first response employee discovered a tech screw had been used to secure a pillar lid by a 3rd party, and on testing, found the screw to be live to 232v.

The tech screw had pieced through to a live phase and made contact.

Removed the metal tech screw.

Test all tech screws used to hold pillar lids in place before removing them.

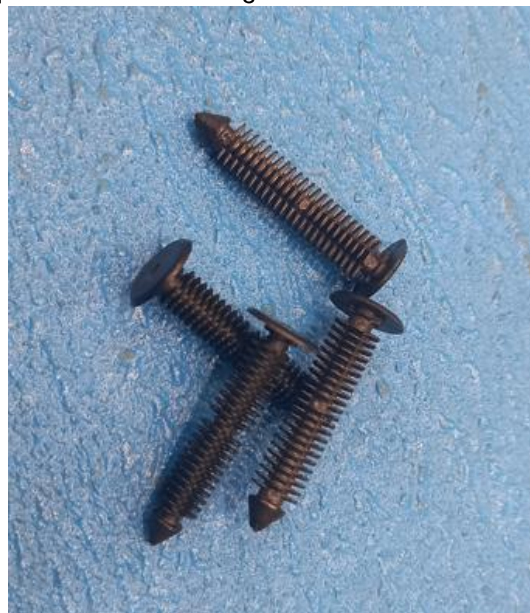
Use the correct plastic retaining screw available in stores and as pictured below.
