## Civil Subcontractor Tip Truck

### Damaging Overhead Comms Infrastructure

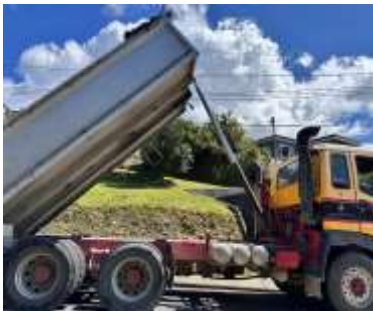
A transportation subcontractor engaged to transport hard fill between two sites in Newlands left the truck's Power Take-Off (PTO) engaged post load release. PTOs allow trucks to power equipment like hydraulic lifts, pumps, or other tools, without needing a separate power source.

The driver travelled through an urban 50km area and at some point, also activated the hoist control lever in the cab enabling the tipping bin to raise in transit lifting it into overhead communications infrastructure causing damage. A small volume of fill was also spilt onto the road.

The PTO was activated after tipping a load and lowering their bin. The hoist control was later accidentally moved into the up position while driving, causing the bin to rise. Driving with the PTO engaged is not industry best practice and risks contact with overhead lines. It can also damage the vehicle.

- All drivers must pay attention to the visual indicators in vehicles – in this case an alert light in the cab indicating PTO engagement.
- While the truck made contact with the Communications Line, it could have been a live distribution or transmission line posing a high risk of contact with electricity.
- All contractors to be vigilant in ensuring staff are always fit for work.
