Cable Snake MAD Near Miss

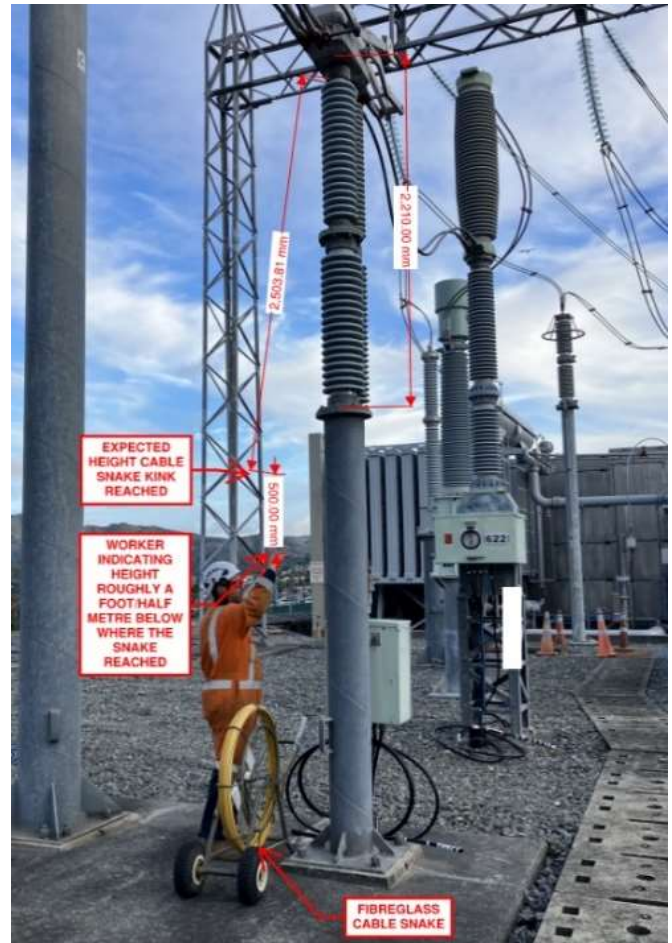
A worker in an intermediate pull pit (away from the reel) pulled back on the cable snake to clear the blockage. An acute belly developed in the cable snake at the reel end, and the belly started to rise vertically into the air.

This continued until the belly reached 30-50cm above head height while under a live 220kV disconnector. The reel was not manned at the time.

It is estimated that the cable snake reached a distance 2.5m away from a live 220kV conductor. Minimum approach distance for a 220kV conductor is 2.2m for a competent worker.

- The hazard was spotted, which the team immediately mitigated by pushing the cable snake back down the conduit to bring the belly down to ground level.
- Transpower and the management team were notified of the near miss.
- Investigation into modifications/alternatives to the cable snake reel took place for understanding of how the belly forms and how to prevent/mitigate.

Root cause was that the reel did not have a team member allocated to it to ensure the snake spools on/off the reel smoothly, which has previously been identified as good practice for this activity in the past.

- Fibreglass cable snakes behave in unusual ways due to their material properties.
- When using a cable snake reel, one member of the team must be allocated to the reel to manage how the snake behaves as it enters/exits conduits as its properties mean it can behave in ways that have potential to breach MAD.
