SAFETY ALERT 25/01

Ladder lost from roof rack

High potential incident

10 April 2025

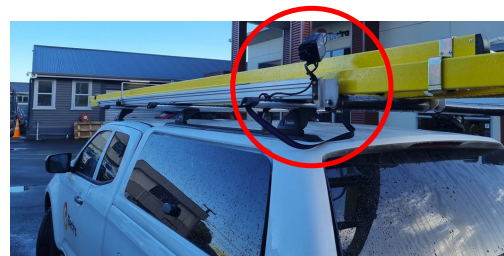
While driving along the Kapiti Expressway in high wind conditions (Monday's weather event), the ladder on the roof rack of a ute came out of it's rack onto the road and bounced over the barrier off into bushes.

This was a high potential incident and a risk to other road users.

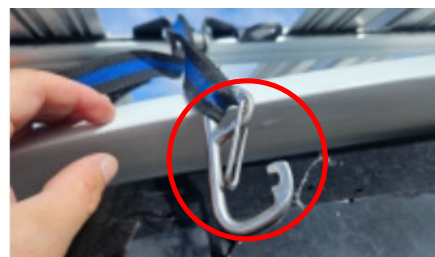
- The ladder is secured by a single carabiner like clip at the rear of the ladder rack. When this is clipped in, the spring/lock should close, and then the cord is tightened to secure it.
- In this case, it appears the clip did not close properly, or was not attached fully, and a significant wind gust has dislodged it, causing the ladder to slide out.

- Roof racks are checked and secure (check and tighten securing nuts as required, this was recently identified as an issue).
- All loads are tied down/clipped in and double checked before driving off.
- Ladder security is checked after every use, again, before driving off.
- Loose items in truck trays must be secured.

- Reviewing whether these clips are a sufficient control.
- Refresher training for tying down loads e.g., poles, transformers, has been recommended during the STCKY review.
