4 July 2025

Crossarm Landed on Foot

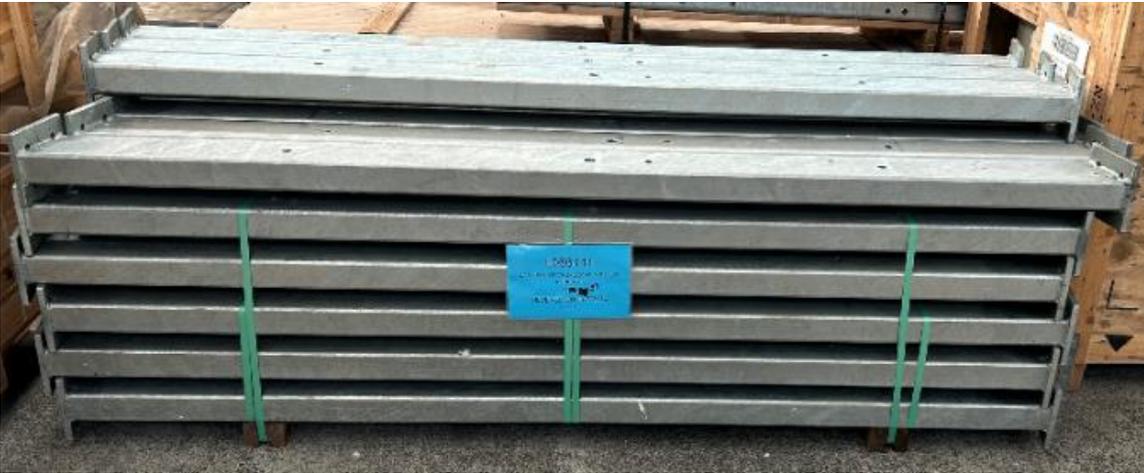
A pole replacement worker was on a HT (heavy traffic) trailer releasing a bandit strap from a bundle of crossarms. As the strap was cut and released, one of the crossarms moved, nudging the worker off the trailer, falling approx. 1 metre onto the ground. A crossarm also fell and landed on their foot. HT trailer had been towed to site by a service provider owned and operated crane truck.

Typical banded bundle of Horizontal Line Post Crossarms

The crossarm bundle was not unloaded using the crane truck, resulting in the worker having to access the trailer to remove the bandit straps from the crossarms, so they could be unpacked.

- Crossarm bundles are to be off-loaded to the ground prior to removing straps by crane truck.
- Stored energy can be present when transporting heavy equipment and hardware.
- Workers to stand clear of equipment when removing straps so not to be in direct path of any stored energy if it were to be released.
- An additional review is being undertaken to explore further solutions to manage this risk.
