# SAFETY ALERT

## Customer Backfeed into Isolated LV Worksite

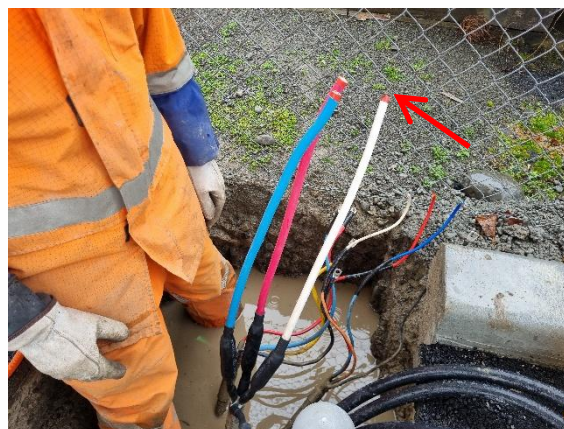
- During a planned LV power outage on 27/06/2025, one of the Cable Jointers noticed sparking when white phase of the LV network cable being worked on touched an adjacent wire mesh fence.
- The work was being done under a MainPower issued LV Permit. The network cable was isolated from the network and tagged. At the work location, the cables were proved de-energised prior to commencing work.
- The Cable Jointer was wearing insulating gloves in accordance with MainPower's PPE Standard.
- The Cable Jointer retested the network cable and identified white phase to be live at 232 volts, and then notified the Control Room.
- There was no harm to persons or damage to property.

Image 1 – Incident location (white phase touched wire fence)

- Notified Worksafe of this incident.
- Conducting a full investigation into this incident.
- Continuing LV Bonding training for LV ground-mounted equipment for additional risk mitigation and SM-EI safety rules compliance.
- Awareness communication to employees and MainPower approved contractors.

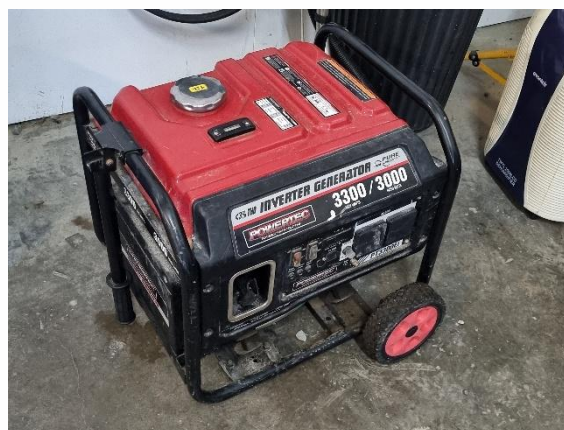
- A customer had relivened their installation via a 3 kW single-phase portable generator and makeshift extension lead with male-to-male plugs. This back-fed the isolated LV network cable that the Cable Jointers were working on, creating an electrically unsafe situation.

Image 2 – Customer connected 3 kW portable generator (source of backfeed)
