# SAFETY ALERT

## What Happened

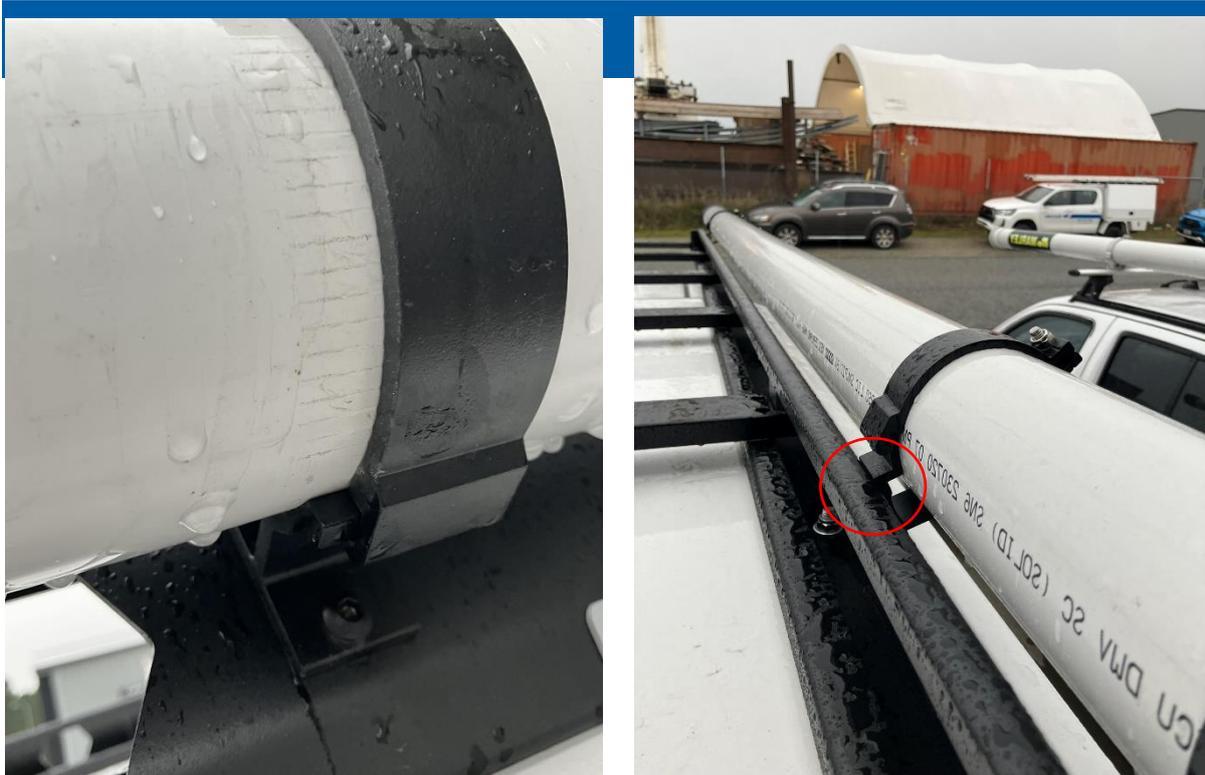
This safety alert is issued due to a conduit carrier falling of a vehicle in an unknown location. After finishing for the day an employee noticed the conduit carrier connected to the roof rack of VQYE257 was missing.

The bracket connecting the carrier to the roof rack was a Rhino Rack K & C Conduit Bracket. As can be seen from the photo on the left of another vehicle checked the bracket on the conduit carrier has begun to move and will eventually detach.

- All fittings on roof racks are to be checked immediately that they are fitted securely.
- All bolted connections should be checked at regular intervals (every 1000k (621mi) is recommended, depending on road conditions, usage, loads and distances travelled). As these vehicles are used in off road activities these intervals should be reduced.
- Whilst doing the monthly vehicle checks all attachments to the roof racks shall be inspected for security as per the check list.
