## Subcontractor Roller Tip Over (SA565)

Incident	Description	
<b>Event Date:</b> 12/06/2025	<b>Time:</b> 15:30	<b>Location:</b> 646 Ormiston Road, Flat Bush, Auckland
<b>Investigation Status:</b>	<b>Closed</b>	<b>NP Reference / External Reference:</b> OCC15534 / Maximo 178841

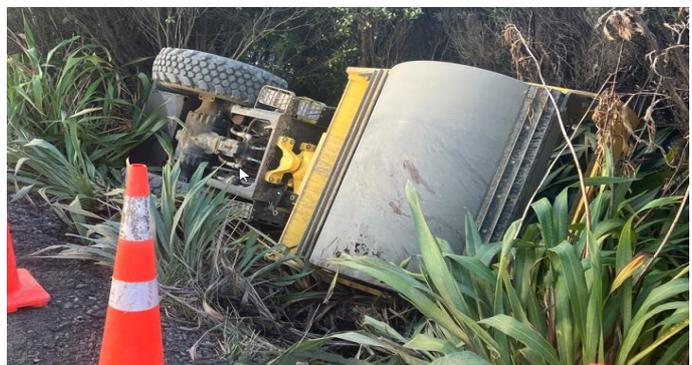
A Subcontractor operator was compacting a layer of ATAP40 along a narrow gravel road after it had been spread with a six-wheel truck. While he was reversing to compact the layers, the operator attempted to steer around an overhanging branch causing the roller's front drum wheel to move towards the swale and hang of the edge of the road. This caused the roller to tip over and end up on its side in the swale. Fortunately, no injuries were sustained. The incident was reported to WorkSafe and has been investigated by the Subcontractor.

- Ensure you are familiar with the environment that you are operating plant.
- Visual deception from bush, grass can lead to severe misjudgement – display visual markers.
- Ensure each section of work must be assessed on its own risk factor.
- One spotter per operation is essential when dealing with high-risk mobile plant movements.
