28 July 2025

Stoke (STK) 33kV Switchgear Flashover Incident

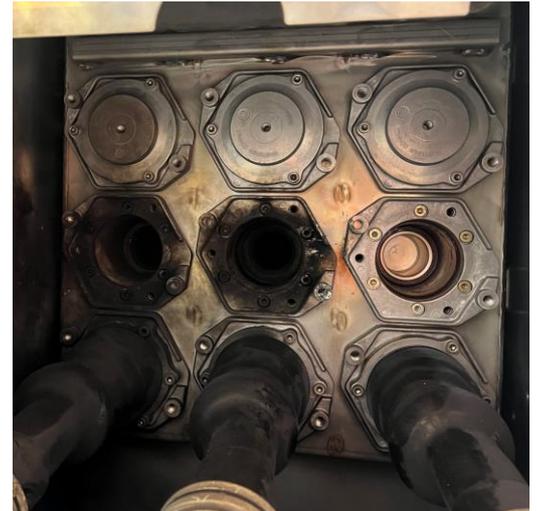
The incident occurred after three dummy plugs were removed live from the inner cone cable termination bushings of Schneider GHA switchgear. The flashover event was initiated by the insertion of a heavy-duty current injection test plug, which caused a blue phase to earth arc flash and then a second concurrent and more intense flashover from the blue phase across to the exposed yellow phase bushing.

Transpower’s investigation has concluded that the root cause was the misidentification of equipment being worked on with several important contributing causes being identified. The arc flashover event was also found to have been more severe than it may have otherwise been, due to all phases being exposed. Crucially the location of the approved voltage detection device (IVIS) is in a different location to the testing injection point when injection testing from a cable basement.

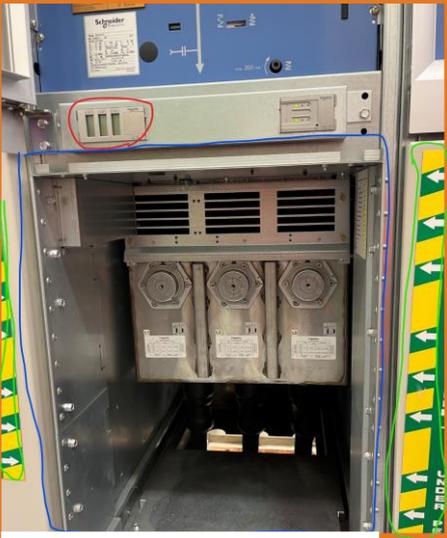
IVIS and removed test access panel.

- The only approved method for proving that GHA switchgear is de-energised is via the manufacturer installed Intelligent Voltage Information System (IVIS).

- All test plans for GHA switchgear shall clearly identify that the test access panel cover must be removed for the duration of any testing, regardless of testing injection location.

- For GHA gear the test panel is currently the best location to test from and removed panels are visible from basements
 - Test plans are encouraged to plan for primary injection via the front of switchgear and to discuss with Transpower any scenarios where this is not technically feasible

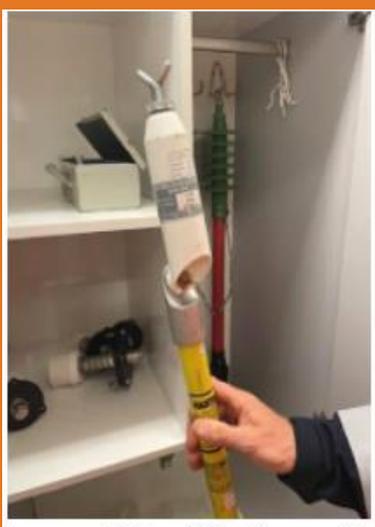
Unapproved Outdoor VDD not for use with indoor metal-clad switchgear

- A Voltage Detection Device (VDD) is not an approved or safe method of proving de-energised for GHA switchgear.
- All primary injection testing must follow a detailed Test Plan, specific to the switchgear being tested
