# FIRST ALERT

## Hydrogen gas leak detected - Haywards Synchronous Condenser 9

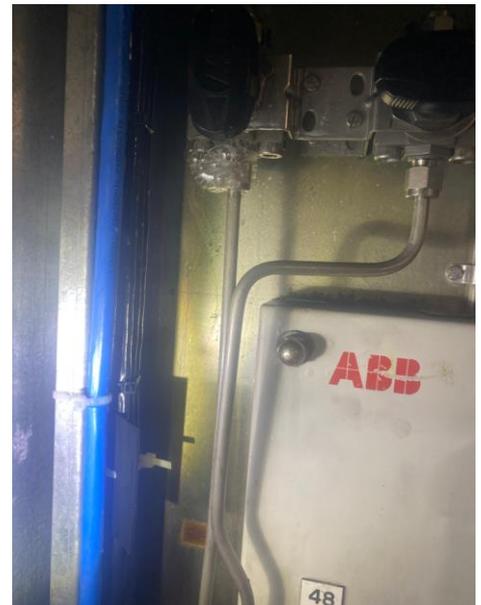
- After Haywards Synchronous Condenser 9 was filled with gas, a low-pressure alarm was triggered by a sensor monitoring the hydrogen pressure inside the condenser. Initial investigations indicate that the leak may have been present since 23<sup>rd</sup> September and was due to a loose Swagelok fitting on valve V32 associated with Kathrometer K2.
- Hydrogen has a very wide explosive range when mixed with air. The hydrogen leak inside the enclosed panel likely created an explosive environment, presenting a risk to people, either from ignition inside the panel itself or when the panel is opened and the hydrogen-air mixture escapes into the surrounding environment where potential ignition sources exist.

- Swagelok fitting was tightened to stop leak, and machine was topped up.
- Daily monitoring to check no further leaks.
- Investigation initiated.
