Beverage can found on tower conductor arm

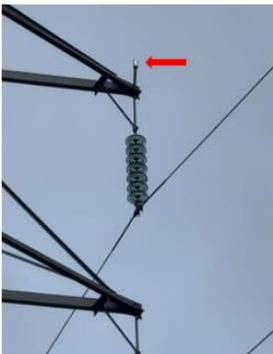
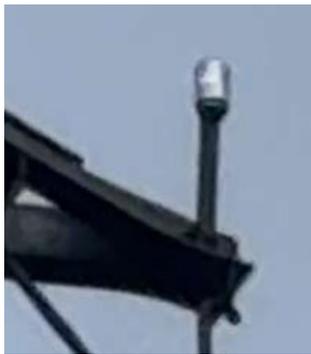
On 16 July 2025, while scoping an access track for upcoming works, a Downer supervisor noticed an aluminium can on the upper insulator on BPE-ONG-AO433, a 110kV transmission tower in the remote Retaruke Valley area in behind Waimarino (National Park). An internal review determined that although there was no evidence indicating how the can was placed on the tower but the method used to secure (forced onto a bird deterrent) indicated that it is likely it was manually positioned and secured which suggests that a person climbed the tower to achieve this.

Image: Photo shows aluminium can (indicated with red arrow in left picture) placed on top of bird deterrent above the upper insulator of Tower 433. The height of the tower is 18m and the location of the can is on the upper conductor arm at approximately 16m from ground level.

Due to the potential risk of falling from height, the incident has been classified as a Level 2 (potential for serious injury). The can remains in place due to the low risk of it falling and requires removal during the next planned outage in February 2026 or via live line techniques. The opening in the can is smaller than standard bird spikes, making removal challenging.
