Omexom NZ Internal Distribution Only

Event Number: 184075
Event Date: 16/09/2025
Event Classification: MTI

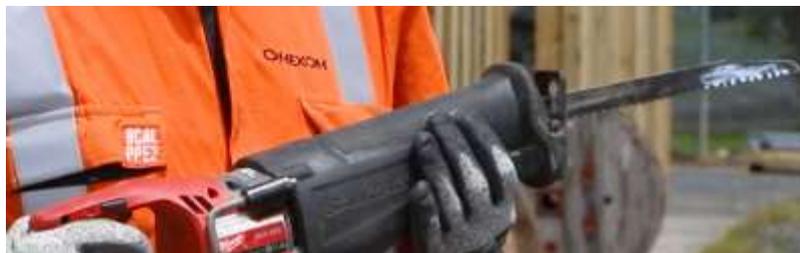
A worker sustained a cut to their hand whilst using a reciprocating saw one-handed, separating pieces of timber that had been nailed together. The one-handed use of the tool resulted in the blade slipping and contacting the worker's free hand.

- Change Management: Last-minute changes resulted in insufficient job preparation and inadequate planning.
- Tool Handling: The reciprocating saw was operated with one hand instead of two.
- PPE: Protective gloves were not worn during the task.

Figure 1 - reciprocating saw used

- Ensure the worker reviews the new Small Tools Guide for the correct practice of tool use.
- Include the Guide for discussion at the induction for new employees.
- Promote the Guide at Inform meetings.
- **Develop an "in the field"** video to inform work teams of the correct practice.

- Always operate a reciprocating saw using both hands to maintain control and reduce risk.
- Good work practices include:
 - Thorough job planning before starting the task.
 - Wearing task-specific PPE at all times.
 - Correct body positioning for stability and safety.
