# SHE ALERT

## Cable Drum Incident

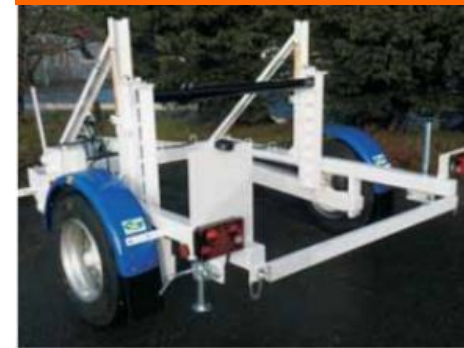
Example of a cable drum trailer

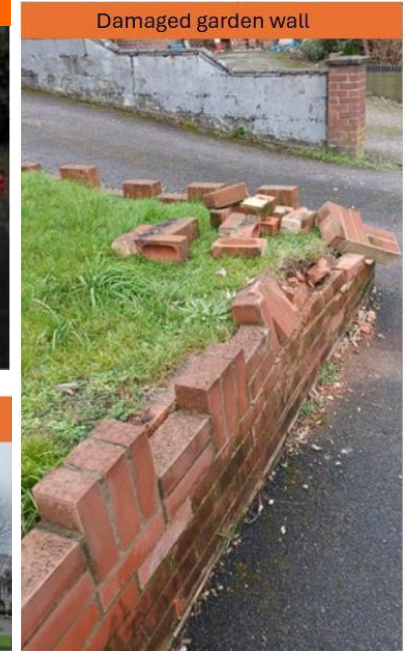
Damaged garden wall

Date of incident	21 <sup>st</sup> January 2025		Directorate	Customer Services.	
Region	Large connections delivery	Location	Yeovil	Classification	PTBW
What happened ?					
<p>A cable drum containing 4-core 300 Wavecon, weighing approximately 2 tons, became detached from a purpose-built cable drum trailer during a vehicle manoeuvre that involved mounting a pavement, rolling 40m down a sloped urban road. The drum caused damage to a garden wall and a parked car but, fortunately, no injuries occurred.</p> <p>Initial Investigations revealed the drum spindle bar had excessive lateral play due to an apparent mismatch with the trailer, potentially contributing to its detachment when the frame twisted as the vehicle mounted a curb. Additionally, the trailer's break-away cable was missing, and the under-run bar was absent, compromising safety.</p> <p>This incident underscores the importance of thorough pre-use equipment inspections and strict compliance with RAMS requirements while the investigation is ongoing.</p>

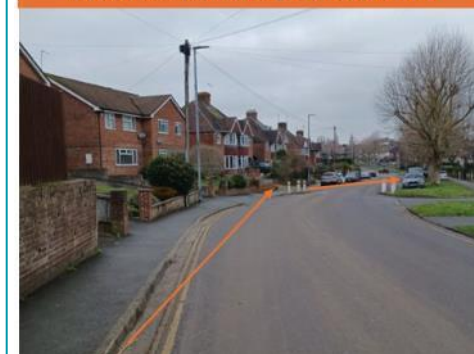
Route travelled by cable drum

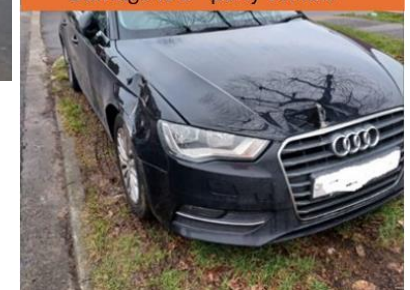
Damage to 3<sup>rd</sup> party vehicle
