# SHE ALERT

## Cable Damage with Hammer

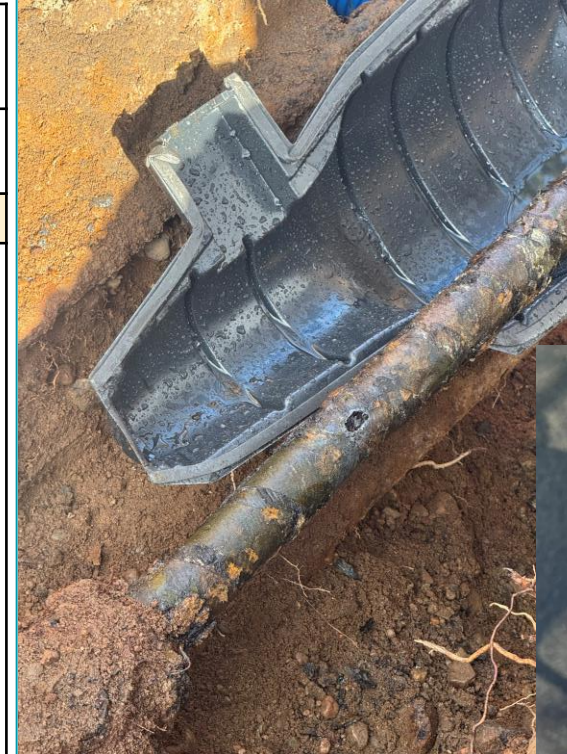
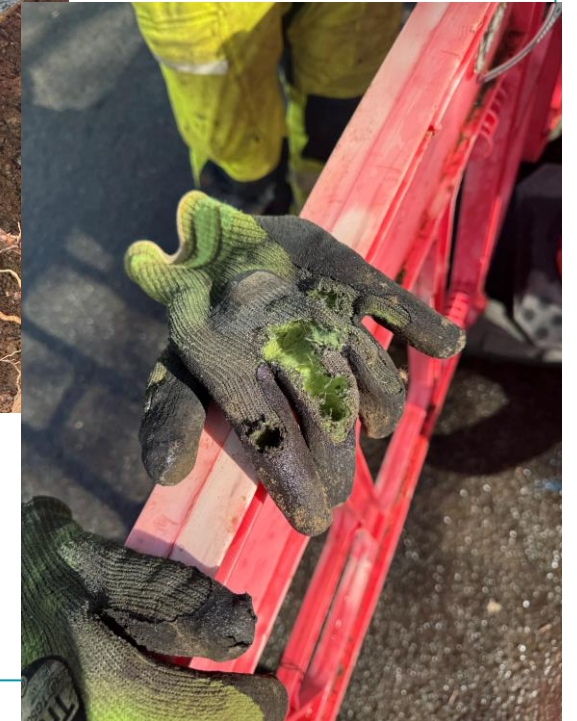
Date of incident	28 <sup>th</sup> March 2025		Directorate	Operations SHEPD	
Region	Highlands & Islands	Location	Inverness	Classification	Potential to be Worse
What happened ?					
<p>While carrying out preparation works for a new connection, a cable jointer started to clear the dirt/bitumen from around a live Low Voltage cable prior to carrying out the jointing works. Whilst clearing the cable armours he was using a hammer to tap off the excess material, during this activity the PILC cable faulted and caused an LV flashover.</p> <p>All correct PPE for the task being worn and no injuries were received.</p> <p>This incident is currently still under investigation and the learning points will be issued as soon as possible.</p>
