SHE ALERT

Finger Injury

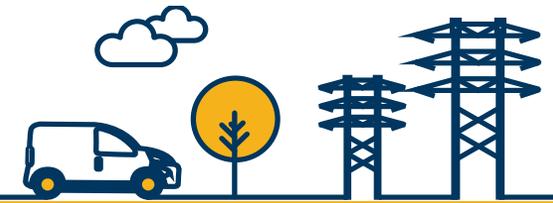
Date of incident	11 th April 2025		Directorate	SHEPD Operations	
Region	Caledonia	Location	Persley	Classification	MTI
What happened ?					
<p>Our contract partner colleague was cutting grass prior to sowing grass seed using a Stihl FS60 strimmer with a blade attachment.</p> <p>In the area being cut, there was a metal peg hidden in the in the grass which propelled up and penetrated their middle finger on their left hand.</p> <p>They attended the local hospital, and the object was surgically removed. The injured person returned to work on the next working day.</p> <p>While the investigation is ongoing, we wanted to share some initial learning points:</p> <ul style="list-style-type: none"> • It is important to choose the correct/appropriate tool for the task. The blade attachment used is more commonly used when cutting woody brash e.g. brambles. • The guard you can see in the picture was removed as it was too small for this attachment and not replaced. Guards should be used with strimmers. • Ensure you are wearing all the correct PPE for the task.
