## SUSPENDED FLOORING - PEDESTAL STRINGERS

This bulletin is to raise awareness of the importance of reattaching lateral stringers and pedestal legs post disturbance.

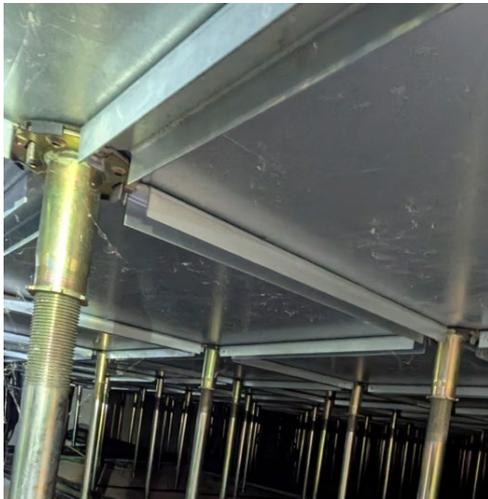
Loose or missing lateral stringers and misaligned pedestal legs have been identified at several substations with suspended flooring. These issues are commonly caused by stringers being removed for subfloor access and not reattached after work or by improper leg alignment.

Lateral stringers are critical for preventing horizontal movement and ensuring the stability of the pedestal leg. Failure to reinstall them can compromise floor integrity and pose safety risks. Misaligned pedestal legs create instability in both the leg and supported floor tiles, and can lead to trips and falls. Please ensure all stringers and legs are properly secured post-maintenance.

- Ensure pedestal stringers are reattached correctly following any work that requires their removal.
- Position the pedestal legs so that the tab spacers align with the floor tiles and the suspended floor system is stable.
- Raise an AIRLine if there are any missing stringers or fixings, if the condition of the suspended floor system is of concern or if standing water is present.
- Be aware that the floor tiles may contain asbestos-containing material. Always consult the asbestos management survey before removing any floor tiles.
