Incident Number: 954901

Incident Title: Potential
livening of 400v cables that
disconnected and the ends
cut (ICAM 56)

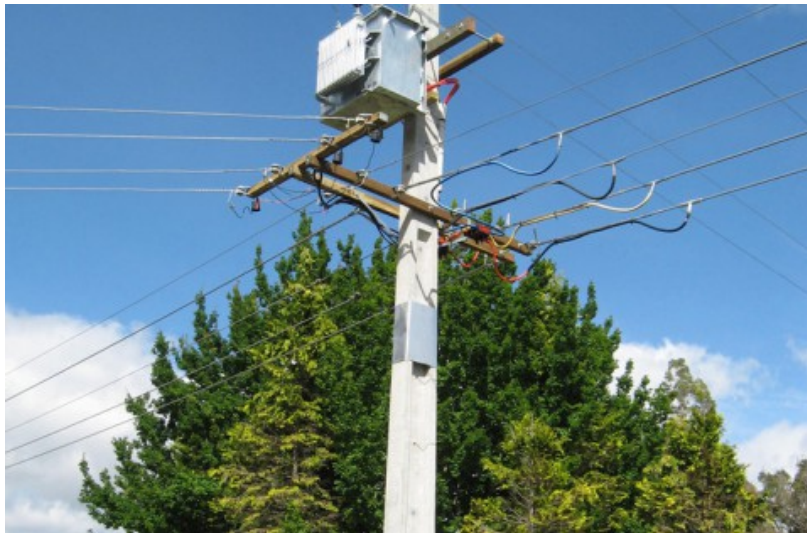
During the livening and transfer of underground equipment in the Frankton region, a PowerNet Central employee stopped the process when he identified that some of the 400V overhead jumpers had not been cut away. The 400V jumpers supplied a decommissioned 400V cable that was cut in half on a pole.

If the circuit had been re-energised it would have resulted in the livening of the cable. This action would have exposed employees or members of the public to the risk of electric shock if the uncovered cable was inadvertently contacted.

1. The process of handover of jobs from the planning phase (Project Manager) to the execution phase (Supervisor) is to be clarified. This is to include:
 - a. Clarification of the responsibilities of the two roles
 - b. A specification of the items to be included in the work pack provided to the Supervisor such as drawings, work schedule, material list, test requirements, HSE and planning meetings etc.
