FIRST ALERT

Finger caught in disconnector pinch point.

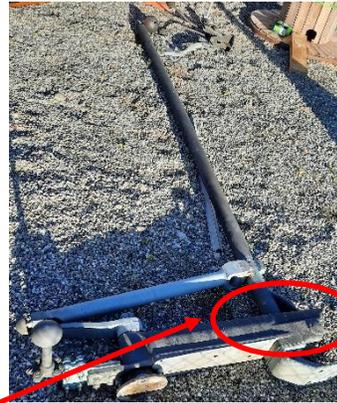
Full arm section (minus insulators) in open position. Note: Switch position was closed when being lifted. Some spring tension was on the DS.

- Stopped work, released the injured person's finger from the disconnector arm assembly.
- Stopped the job and discussed the disconnection and breakdown process of these disconnectors at the morning team meeting the next day.
- Initiated an investigation to identify the root cause and the required actions to prevent a recurrence of this type of incident.

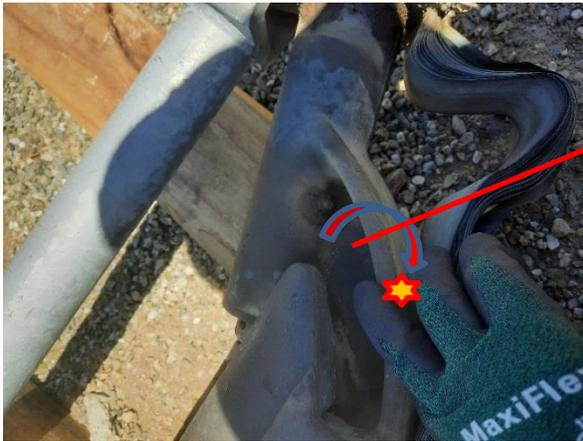
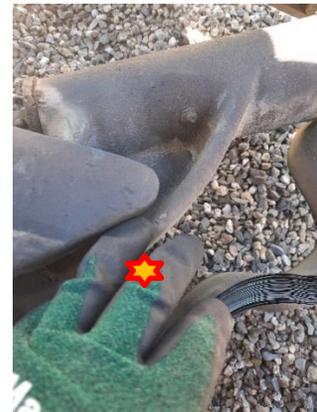
- Whilst dismantling a Canterbury Engineering 220kV Disconnector Switch (DS) on the ground, a worker's finger got caught between the male contact arm and spring-loaded cast gunmetal section as it was being lifted.
- The worker sustained a laceration to his finger and was taken immediately to the local Medical Centre where he received three stitches.

Finger position under the casting when being lifted. Note: when arm moved it trapped the IP's finger (right photograph).
