Date of Incident: 21 September 2020

## NEAR MISS – POTENTIAL SECURITY BREACH

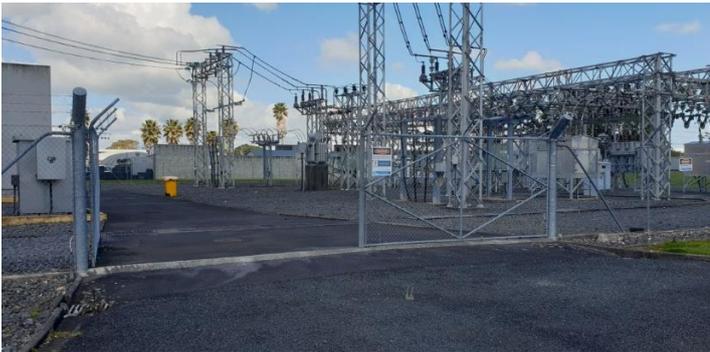
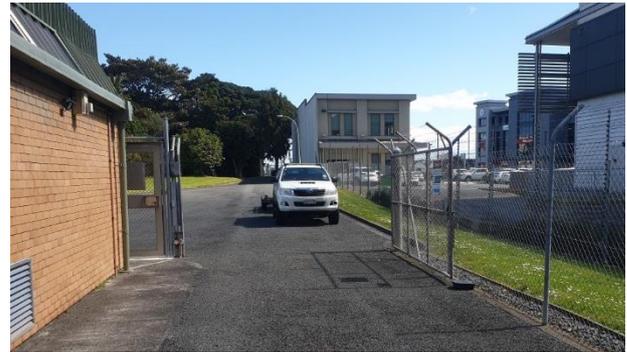
Wiri Substation: A maintenance contractor left the vehicle gate in the security fence and, the vehicle gate into the ODS structure open while undertaking grounds maintenance in a restricted area of the substation. Both gates were not being supervised posing a security hazard for unauthorised access into a restricted area. The gates were left open/unattended while spraying weeds from a pre-prepared spray tank for an undisclosed period of time.

Although the contractor was aware and understood his responsibilities on site, the contractor wanted to complete the maintenance task as easily and as quickly as possible. The contractor was alerted when approached and quickly closed and locked the gates.

Substations are to be secured against unauthorised entry always. The public must be kept safe from work taking place and worksite hazards when the site is unattended.

Gates into restricted areas such as switchyards, other HV enclosures and buildings shall be kept locked unless the entrance gate or door is continuously monitored under close supervision.

Note: Controlled area gates left open for any reason shall be supervised to prevent public access.

All staff working on substations are to be reminded of the responsibilities and requirements from Transpower's controlled document, Station Security Procedures - TP.SS 07.40.
