# SAFETY ALERT

Wood Engulfment - Dunedin Energy Centre

| Date of event | 7 June 2026 |

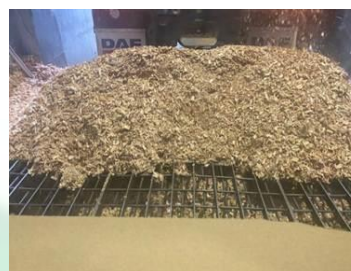
Woodchip bridging on the grate above the fuel hopper.

**Design and layout constraints** – The bunker and grate layout contributed to recurring blockages, increasing the need for manual intervention.

- **Engineering Controls:** Where a task regularly requires manual intervention near stored energy or mobile plant, engineering solutions to reduce or eliminate that need should be reviewed ahead of relying on procedure alone.
