# SHE ALERT

## Cutting Trees in the Live Zone

| Date of incident | 16/04/2026 | | Directorate | Distribution – Services SEPD | |

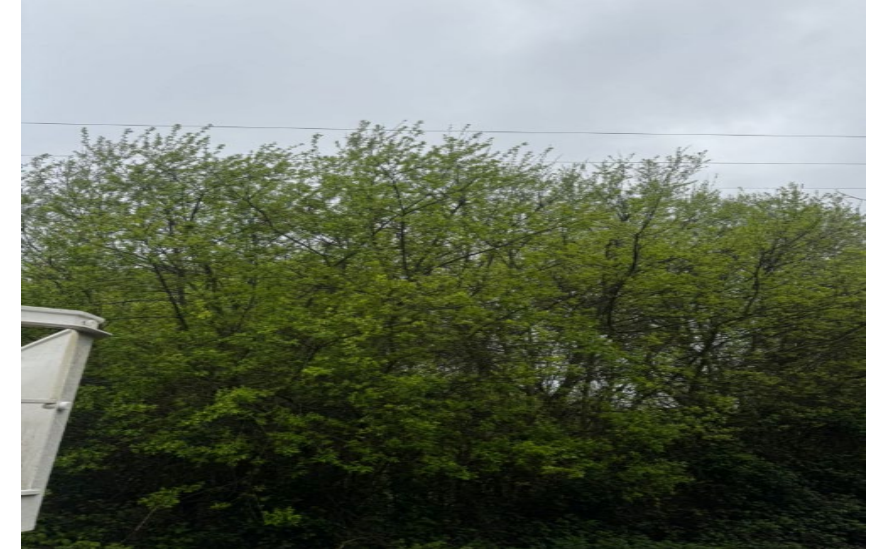
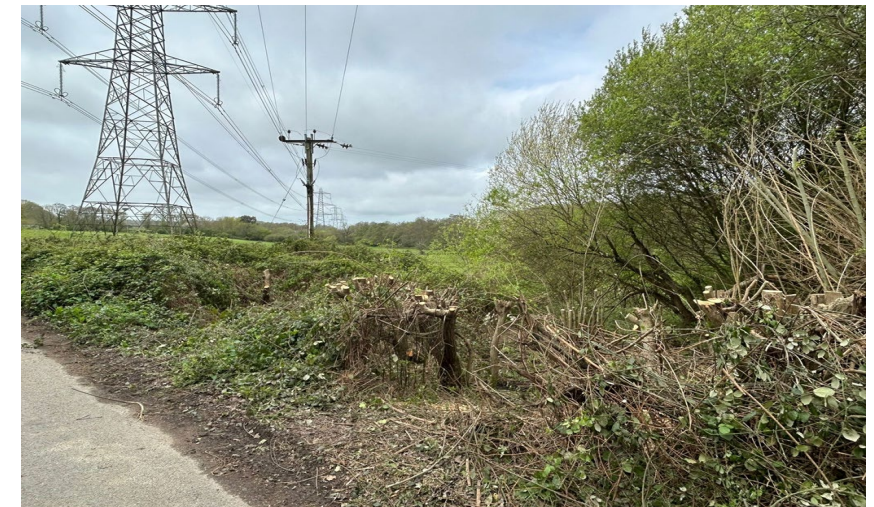
| <p>A Contract Partner utility arborist team had been working on Category A/C trees below and adjacent to an 11kv line. Prior to the incident, the arborist was cutting small willow stems deemed category C, with a chainsaw at ground level.</p> <p>The arborist then cut a larger diameter stem (3-4 inches) which stayed in place on the stump of the cut but infringed the live zone (LZ) of 0.8m He subsequently decided to put his saw down and he remove the stem by hand.</p> <p>Whilst we investigate, we would ask all utility arborists to ensure that the SSE procedure (WI-NET-OHL-038 - Tree Cutting Works Adjacent to Live Overhead Line) is understood and followed. Please ask your SSEN-D point of contact to confirm the latest version</p> <ul style="list-style-type: none"> <li>• If the vegetation you are cutting has the potential to breach the live zone (LZ), the control measures and work method chosen to comply with this work instruction, including, where relevant, the maximum length of cut section, must be agreed and recorded on the risk assessment</li> <li>• Any Branches breaching the Live Zone must be removed with insulated tools.</li> </ul> | | | | | |
