# SHE ALERT

## Side Panel Detaches from Trailer During Transit

| Date of Incident | 1 <sup>st</sup> June 2026 | | Directorate | Services SHEPD | |

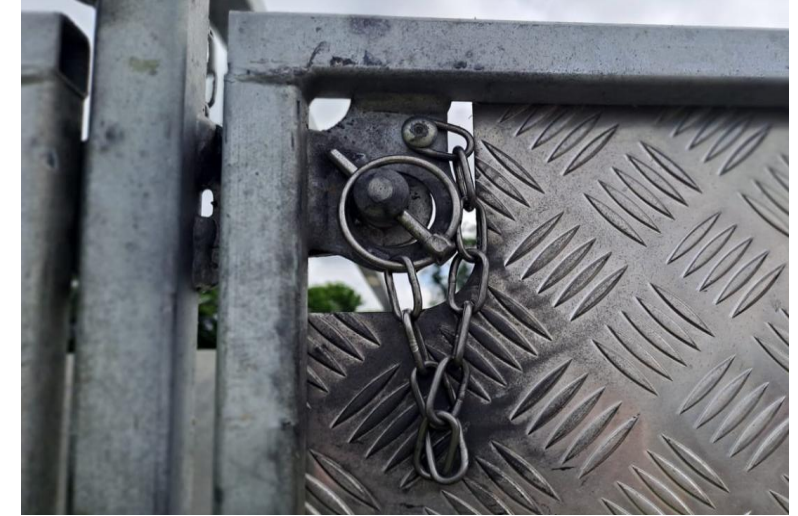
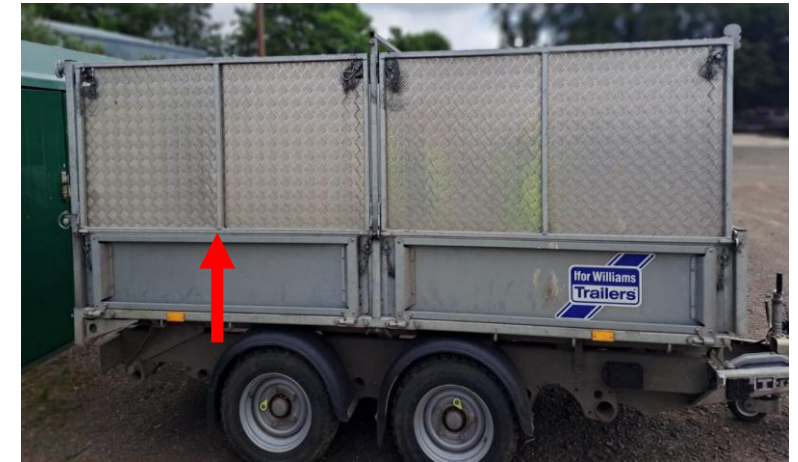
| <p>While travelling on the A92 near Montrose, a side panel (as shown opposite) detached from a box trailer and fell onto the roadway. A vehicle following behind was able to stop safely and avoid collision.</p> <p>Prior to the incident, the vehicle had passed over a rough section of road. It is believed that the retaining pin on the right-hand side of the panel became loose, causing the left-hand side to disengage due to movement.</p> <p>The driver brought the vehicle to a safe stop and successfully retrieved the panel.</p> <p>While investigations are ongoing, this incident serves as an important reminder of the need to ensure all pins and fixings are secure and correctly fitted during daily trailer checks.</p> | | | | | |
