SAFETY! ALERT!

Cable Damage During Backfilling of Trench

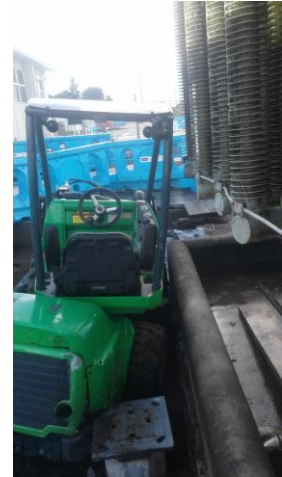
A pivot steer mini loader was being used to backfill an 11kV cable trench with constricted access at Kawerau substation. As a load of fill was about to be placed over the live cables the mini loader became stuck in a noncompacted area of the trench and on top of the cables. The machine became wedged in at an angle and the decision was made to lower the bucket keeping it flat and attempt to self-recover.

An outage was arranged to allow hand excavation at which time it was found that one cable sheath was damaged and a second cable was damaged to the screen.

- Work stopped and recovery completed using a telehandler.
- The suspected damaged cables were barriered off until an outage could be arranged for close inspection. The damage was inspected and successfully repaired.
- A full investigation is under way.

- Workplans must be detailed enough and communicated to ensure all involved understand the methodology.
- Work must not start unless an appropriate plan and hazard assessment are in place.
- Work must stop and be reassessed when the plan changes or something goes wrong.
- Backfilling of trenches in the proximity of cables must be planned and managed as per excavation practices.
- During backfilling of excavations, a machine should not be driven over the backfill until it has been compacted as per specification/design.
