New Model for Seismic Loads on Pole Mounted Assets

Dale Donovan | 20 May 2026

Using Soil-Structure Interaction Model for Pole Mounted Assets

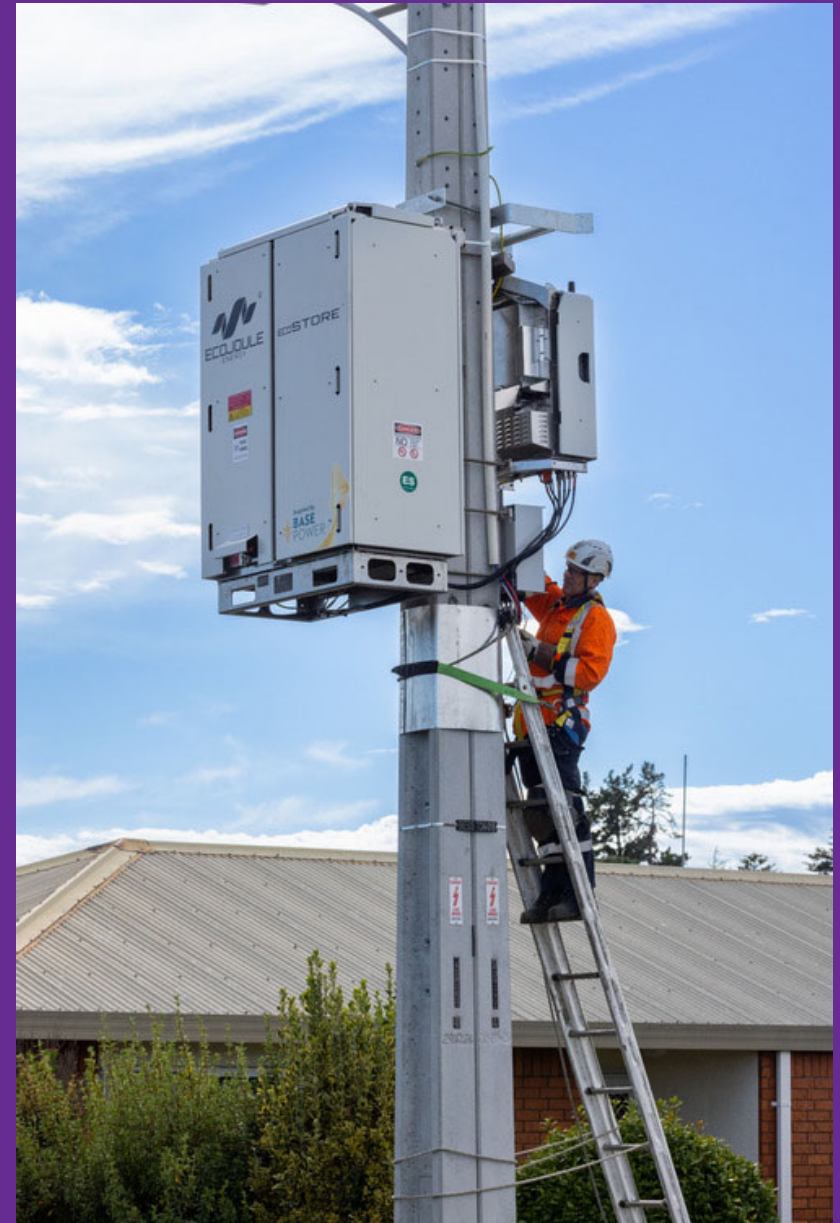
- Bess Pole Mounted Batteries
- Busck Poles
- Low Seismic Area (Tauranga) earthquake loads still governed design
- Designs unable to evaluate pole foundations

Focused on Double Busck 11m with a 1000kg weight
Including foundation aids, i.e. Breast Blocks and Donuts on standard design

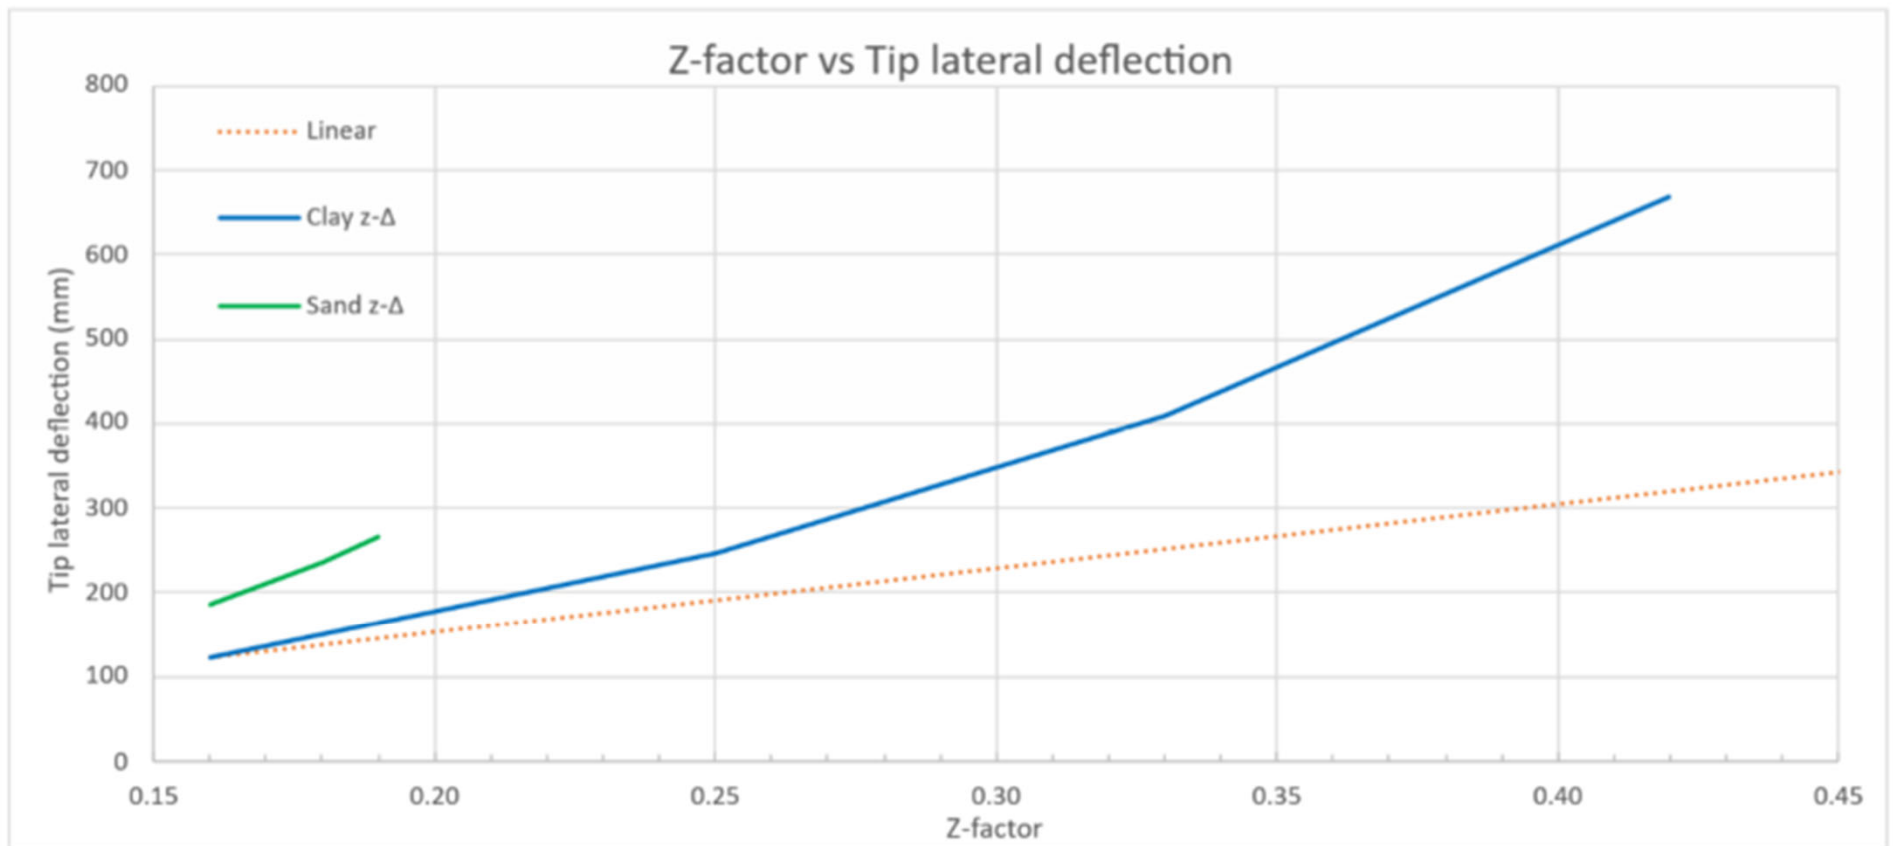
Figure 8 Z-Factor vs Tip Lateral Deflection

Poles behave elastically under all assessed seismic loads - all North Island Z values

- In Cohesive Soils existing poles are able to resist the maximum expected seismic demands, $Z=0.42$
- In non-cohesive soils the poles are able to resist seismic loads up to Z of 0.19, may be able to increase to 0.26 (Wanganui and Christchurch)
