# Ground Stay Anchor Testing & Design Implications

Antony Cochrane  
Andrej Kujikis

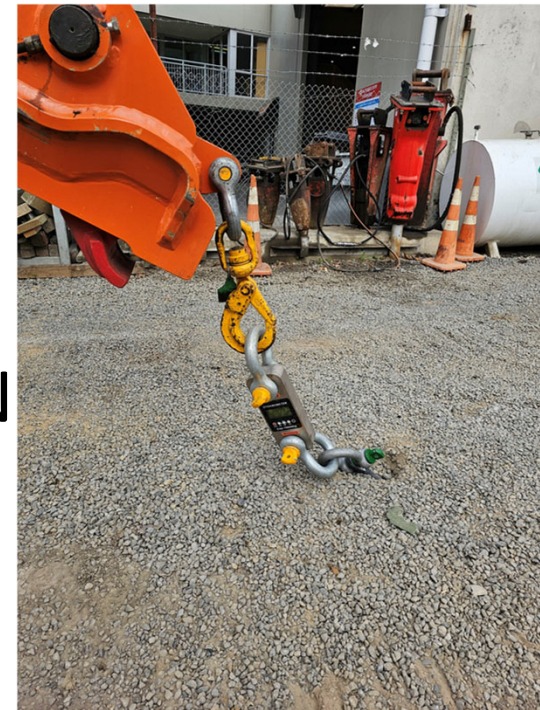
# Testing Methodology

- 25T excavator used for pull out testing
- Calibrated wireless dynamometer
- Incremental loading applied
- Maximum available applied load = 100kN

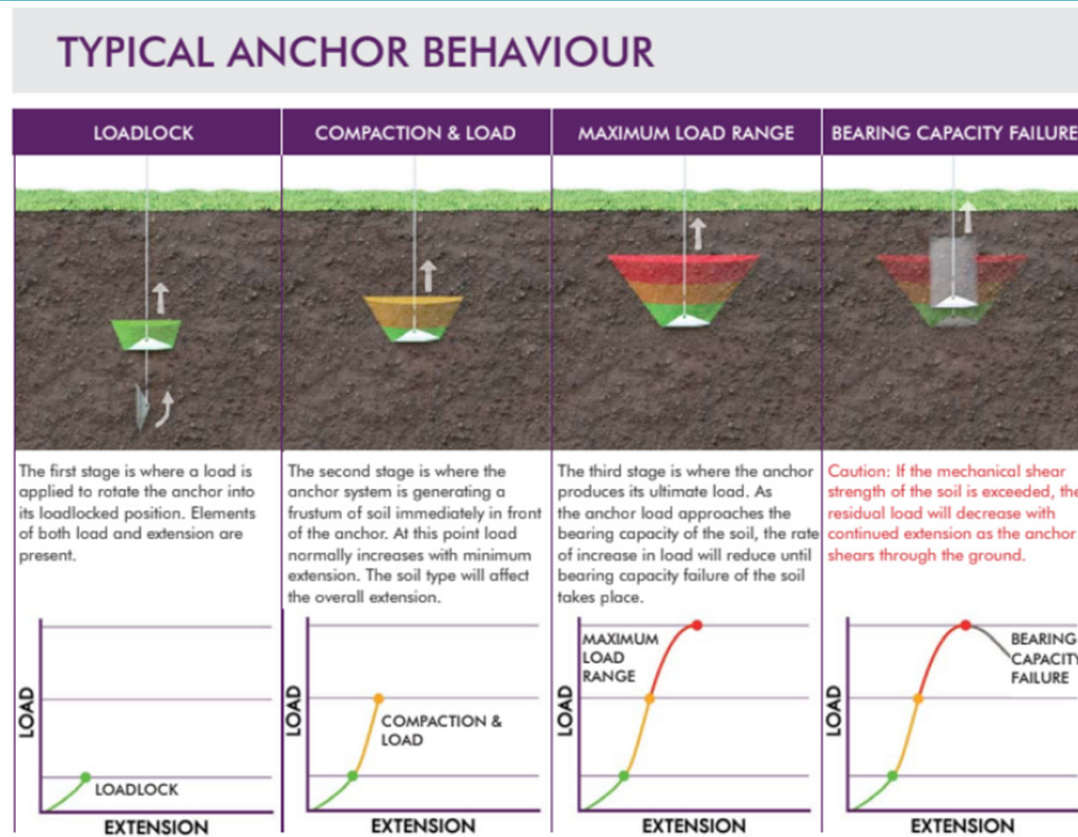
Slide 16

# The Expected Load Curve

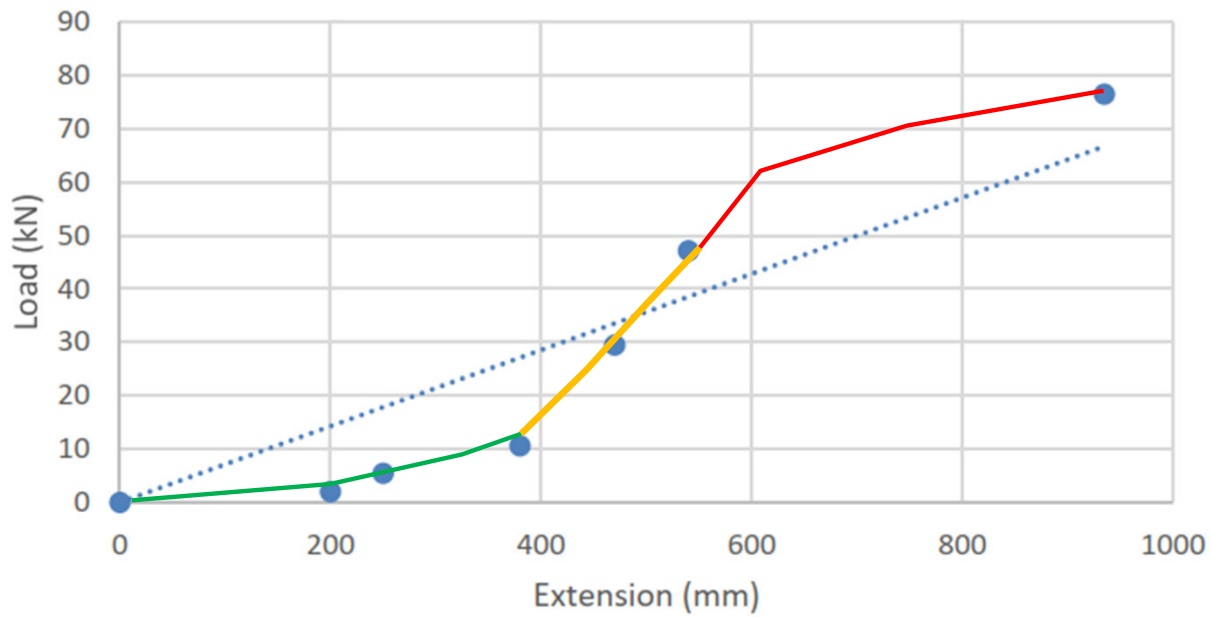
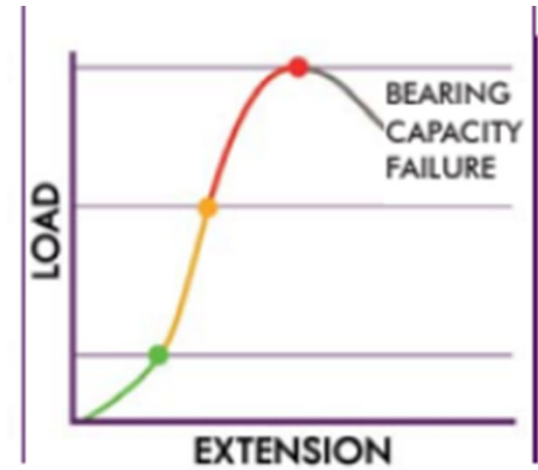
Slide 17

# Tested Load Curve – B6

Platipus B6 testing

- B10 – 79kN
- B8 – 74kN
- B6 – 76kN
- B4 – 73kN

All failures were from tendon fracture

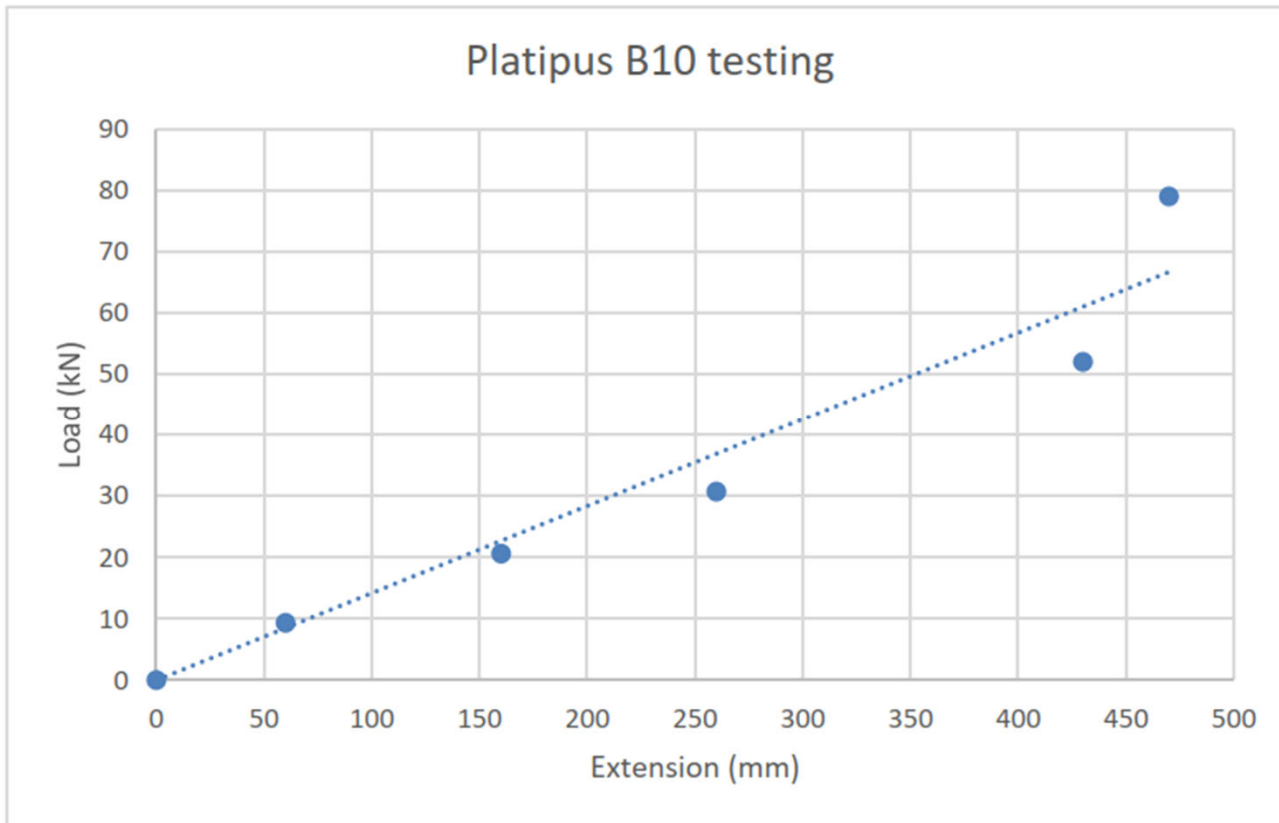
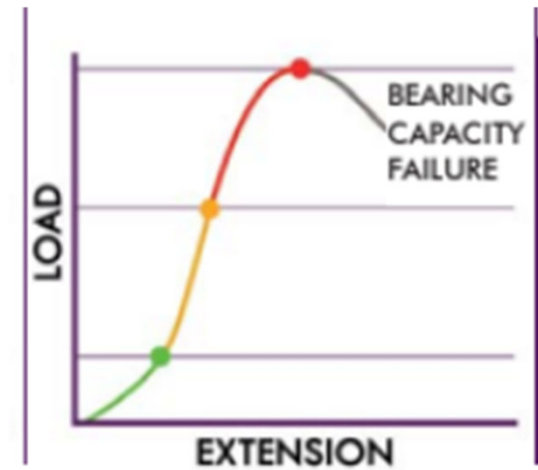
Slide 18

# Tested Load Curve – B10

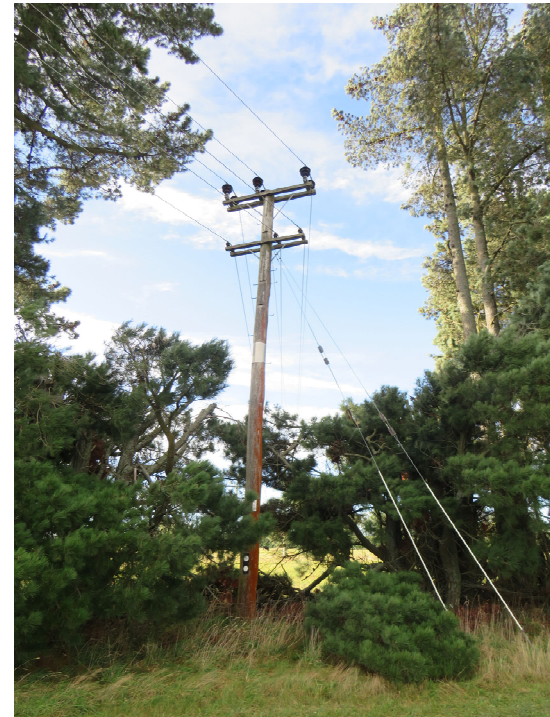
# Typical Scenario – 30° Deviation

- Orion's Humble Str. CB110
  - OB3.1 , 33/11 kV, ACSR Dog
  - Site Elevation 172m (35mm Snow)
  - 14m 20 kN U HW
  - Replace w/1x guy, 7/3.15 Ø9.45mm
  - Guy angle -> 60° (site constrained)
  - 41m Ahead/33 m Back Spans

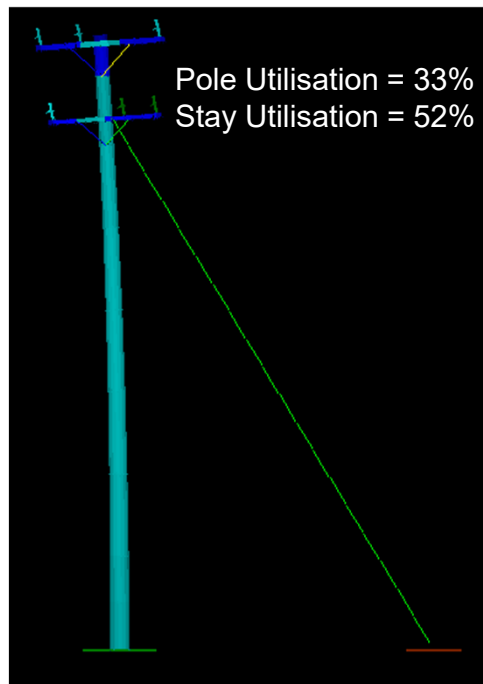
# Typical Scenario – CB110

## 20 kN U Hardwood Pole

2000x300  
HW Anchor

- Reducing the anchor stiffness will increase the pole loads and pole deflections.
- Higher utilisation poles have less tolerance for defects and degradation.

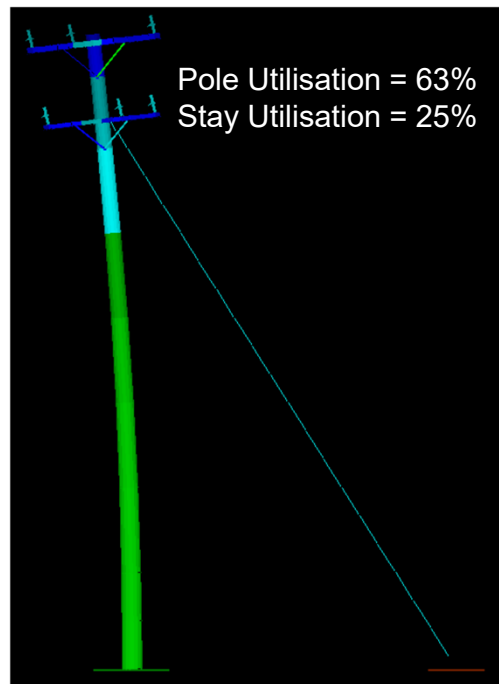
B10 Anchor

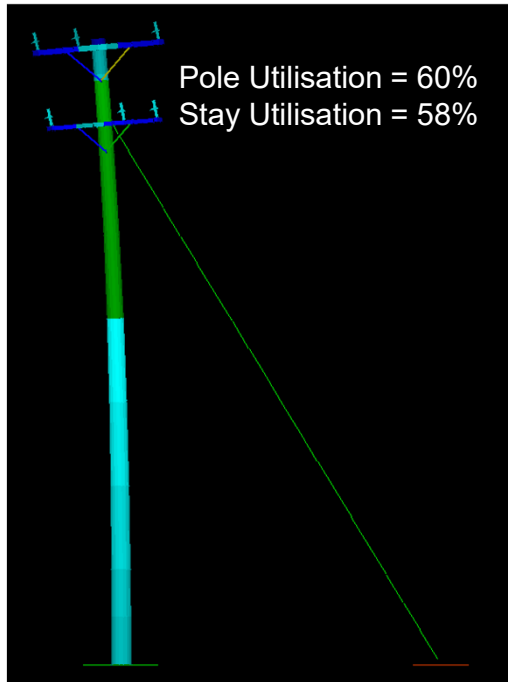
# Typical Scenario – CB110

## 12 kN U Softwood Pole

2000x300  
HW Anchor

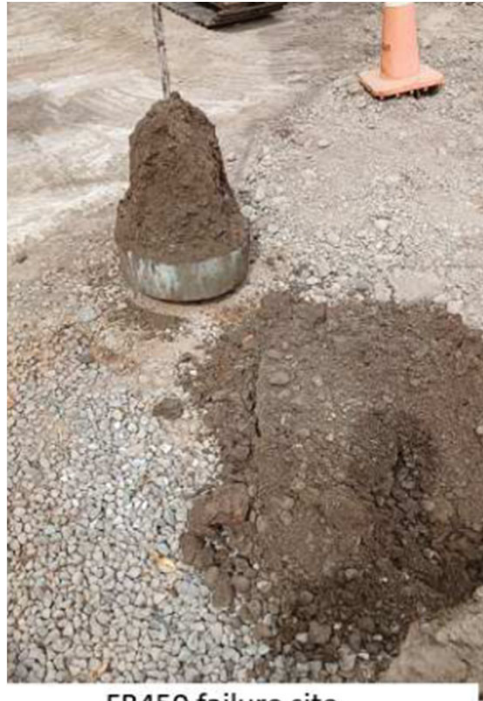
FB450 failure site

- Standard anchors were unable to be tested beyond the 100kN capacity limit of the testing apparatus
- Minimal displacement observed
- Installation of these anchors requires substantial excavation and reinstatement of the surrounding ground
- The concrete anchor block option offered lower bearing capacity resistance (57kN)\*
