# Safety Alert

**Event Number:** Maximo 96516

## Tail Gate lost from Trailer in transit

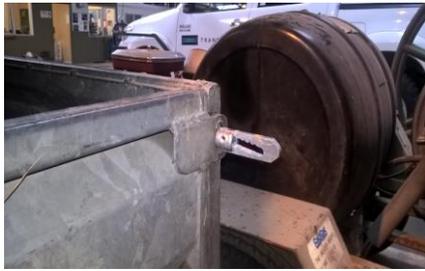
Picture 1: Standard trailer latch in open position

**Contributing Factors:** During travel the trailer tail gate latches have shaken into the open position allowing the tailgate to swing down on its hinges, and slide off the hinges, and fall from the trailer.

**Actions to Prevent Reoccurrence:** Trailers are being fitted with retaining clips attached to a tether, that clip through the trailer latch, and through the tailgate hinge pins, to remove the risk of tailgates becoming unlatched and falling from the trailer in transit.

**Lessons Learnt:** Check all trailers are fit for purpose prior to use. If tail gate or side latches are worn or loose, secure them with lashings/binder or ties until they can be replaced or have retaining clips fitted.

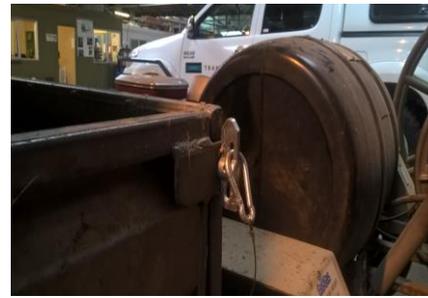
Picture 2: Latch with retaining clip and tether installed
