Incident Alert

Follow up Industry Alert: Electric Shock During Testing

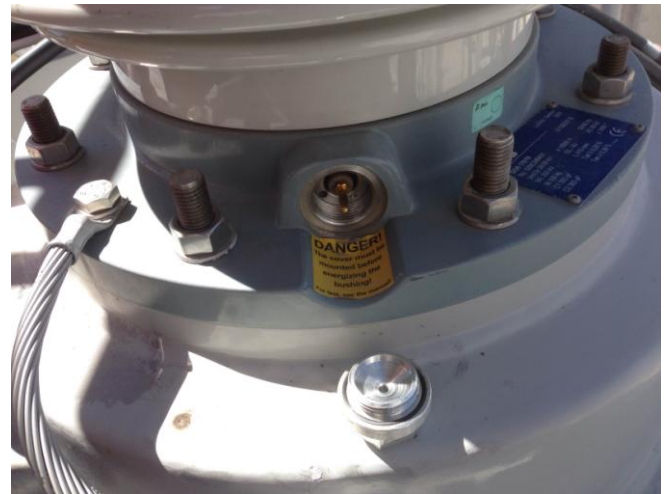
Fig. 3. Previous design of adapter for temporary connection to test equipment 2643 762-A.

Bushing test tap

- 1) Clamp nut for test cable
- 2) Insulation sleeve
- 3) Barrel nut

Adaptor for testing

- When working on equipment that has specific test terminations ensure the correct test leads and connectors are being used. In this case these are available for purchase from ABB Sales Support 06 755 9525

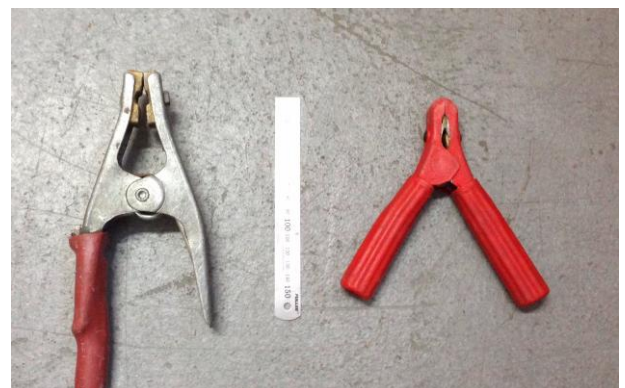
While conducting power factor testing on a transformer it was found the test leads would not stay in place during the test. The work team decided to have someone hold the lead by the insulation to enable the test to be completed. While carrying out this action the person has received an electric shock on the arm.

Test Leads used in incident
