SAFETY ALERT

Waitaki Dam Hoist Failure

Friday 12th June 2015 at 1730 hours

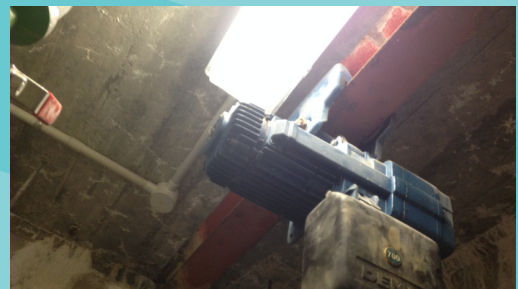
PHOTO:

On Friday afternoon, when the load was approximately 1m from the top of the shaft, the hoist stopped again. They lowered the load slightly and when they raised the load again, the hoist failed and released the chain. The load fell down the shaft.

Enquiries were made regarding the certification and maintenance of the hoist, which transpired that it had neither. On further investigation it was found that as the hoist is on rail, then it should have been classified as a crane and is subject to certification. A number of similar lifting systems are present at other hydro sites, and an instruction was issued to the Hydro Site Managers to identify and tag out similar lifting systems.

- Site Managers should identify if they have any Demag DK2-250V1/1 hoist (or similar). These should be fully inspected, with a focus on ensuring that the plastic chain guide is secure and not showing signs of wear.

- All safety procedures including marked drop zones had been identified and were followed and as a result no one was injured in this incident.
- The contractor's instinct was to grab the slacked chain. This put this individual at risk, and it is recommended that people don't try and stop falling objects.

- Project Managers, Engineers and Site Team should question the current certification of equipment, especially if the equipment is going to be used in a different manner or the use is following an extended period of not being operated.

- Identification and certification of similar lifting systems across all sites is currently being undertaken.
- As the falling load hit the middle ladder landing, it was not known what damage was done to this suspended structure. The ladders were taken out of service until it could be inspected by an appropriate qualified Engineer.
