Safety Advice 20-2014- (Mar) (NZ) *(Transmission)*

FIRST ALERT

STK-UTK A and B Saxtons Field Re-alignment

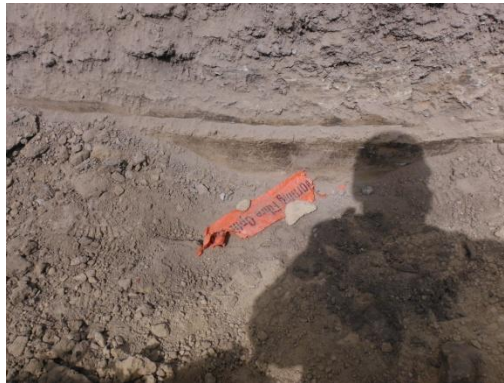
When excavating for the installation of a deadman anchor the excavator came into contact with danger tape approximately 400-500mm below ground level. The danger tape indicated the presence of 33kV cables.

- Actions taken. Crew stopped work and notified the Project Supervisor. The Project Manager then notified the local ESA authority that came out to site and confirmed that there were two 33kV underground cables and one fibre optic cable in the immediate vicinity.
- Cause: An underground services location for this site had not been undertaken prior to work commencement.
- Learning's: A permission to dig permit system is to be implemented to ensure underground services have been checked in the affected work area. An interim internal excavation approval process has been implemented with all relevant documentation, including (Before U Dig), sighted by senior management before an internal excavation permit will be issued to the work crew as a temporary measure.
