# SAFETY NOTICE

Electricity: ISSUE No. 0006

On May 2<sup>nd</sup> 2014, a Powerco contractor was setting up to undertake a 33kv cross-arm replacement using a live line procedure.

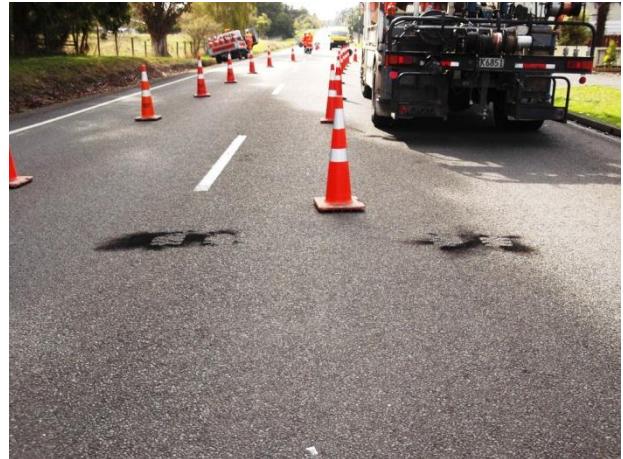
- A safety observer was not used at the point where contact occurred
- Resource and logistics support to the crew was suboptimal
- The **Portable Temporary Earth** applied to the leg of the Hi-Ab did not completely mitigate the fault current flowing through the vehicle (note the carbon scorch marks on the road surface in the upper photo)

Powerco wishes to reinforce the importance of ensuring that in addition to other existing safety measures, appropriate **Equi-Potential Zones** mandated by industry best practice are applied to all tasks where risk of contact with electricity is present.

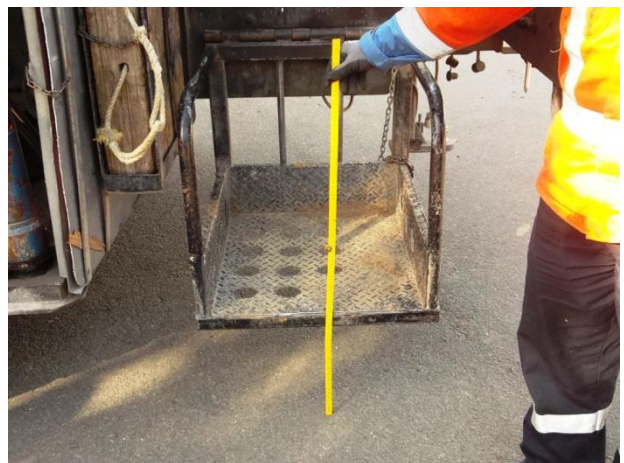
As part of the setup activities, a lifting rig was attached to the vehicle mounted crane and moved into position. During this action, the lifting rig came into contact with the live 33kv road-side phase, causing the circuit to trip.

The investigation also identified specific defenses that worked effectively. The operator was standing on a metal operator platform. This platform created an **Equi-Potential Zone** which resulted in the operator being completely unharmed. Additionally, separation of the other workers from the earth stake and connected vehicle served to prevent harm.
