Safety Advice 32-2013 (Aug) (NZ)

Incident Alert 4215 below pertains to a water blast incident causing a serious harm penetration injury that occurred in August 2013. This Incident Alert is shared with the wider industry to raise awareness of water blasting hazards, courtesy of the StayLive Group, and is published as EEA Safety Advice 32-2013

High Pressure Water Injection Injury

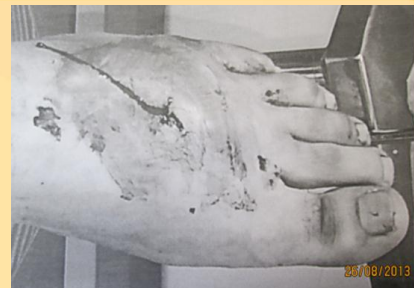
On 23 August 2013 a contractor performing high pressure water blasting inside the generator penstock received a high pressure water injection injury to his left foot.

The contractor stepped off the work platform to remove debris from the floor of the penstock. As he adjusted his footing to brace against the pressure of the water lance the contractor slipped causing the water lance to cross over his left foot twice puncturing his gumboot and injecting water and debris into his foot creating a puncture wound which required minor surgery to remove water, air and contaminants..

1. A thorough risk assessment is completed prior to high pressure water blasting work activities being undertaken.
2. Ensure any person performing high pressure water blasting wears fit for purpose personal protective equipment i.e. Kevlar lined overalls and spats/gaiters designed to protect foot wear.
3. Ensure persons operating high pressure water blasting equipment have sufficient skills and training to operate high pressure water blasting equipment i.e. training records etc.
4. Ensure adequate fall protection and head protection such as a five point impact safety helmet is worn and the person is attached at all times.
5. Ensure the length of the water lance is such that the head of the lance cannot inadvertently come into contact with any part of the user's body.

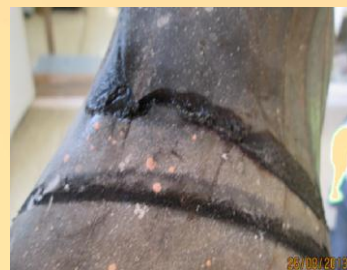
The ensuing investigation identified:

1. The personal protective equipment used by the contractors was not fit for purpose.
2. Although the contractor had significant experience in this field he was unaware of the extent and potentially fatal consequences of an injury sustained as a result of a high pressure water injection.

1. Where work to be undertaken is of a hazardous nature such as high pressure water blasting, clarification should be sought from the contractor at the tender phase on how work activities including safety procedures align with the applicable AS/NZS standard or equivalent international standard in this case AS/NZS 4233.1.1999 High Pressure Water (Hydro) jetting systems, Part 1 Guidelines for safe operation and maintenance.
