## *Safety Advice 04-2008 (NZ)*

### **Ladder Failure**

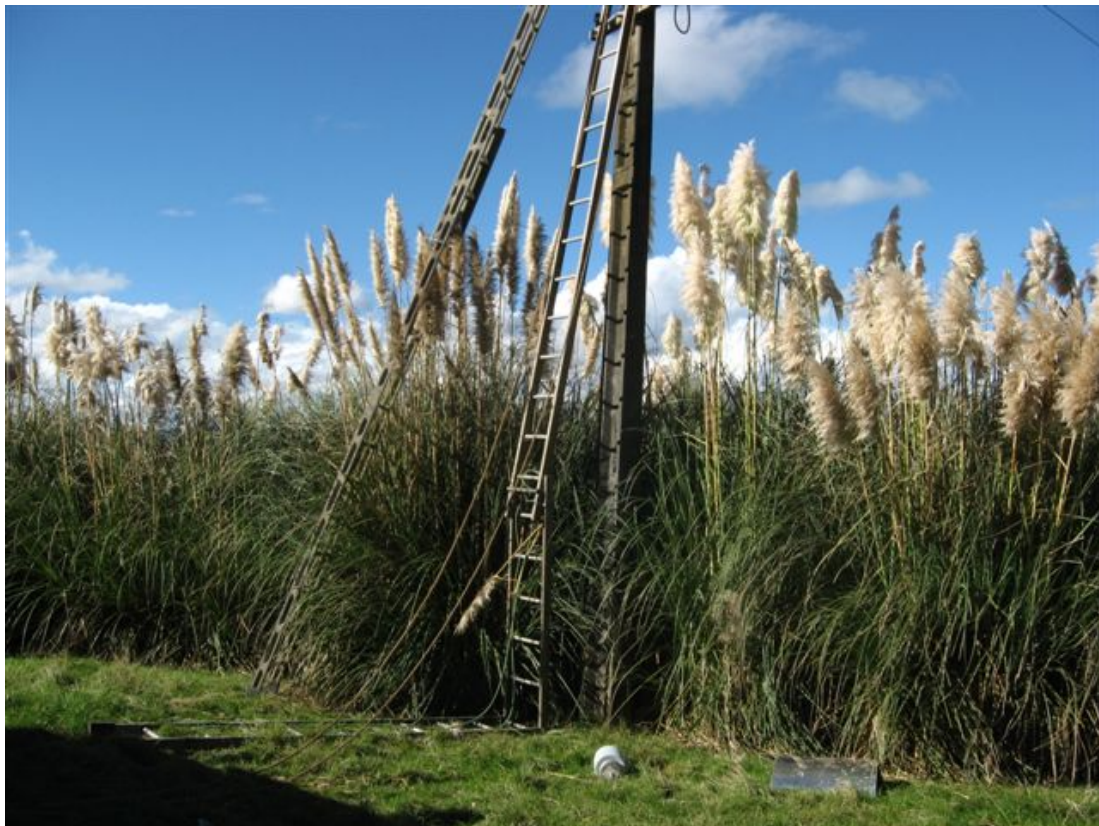
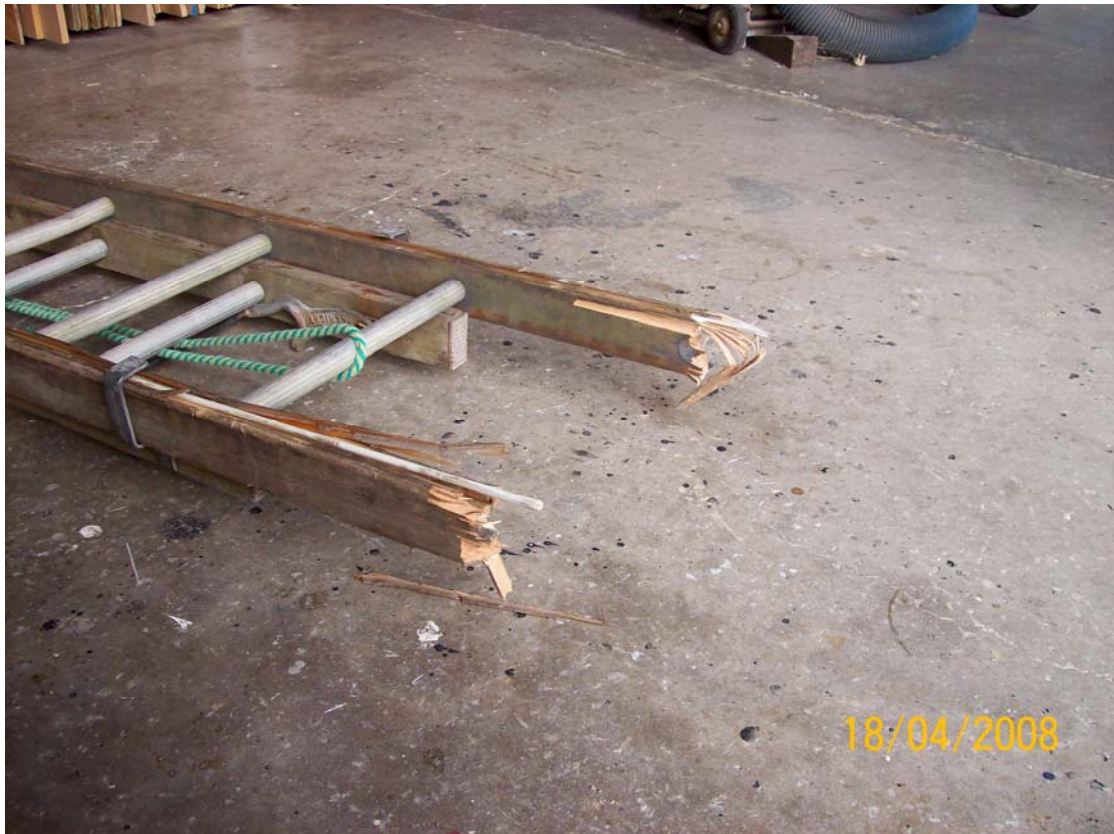
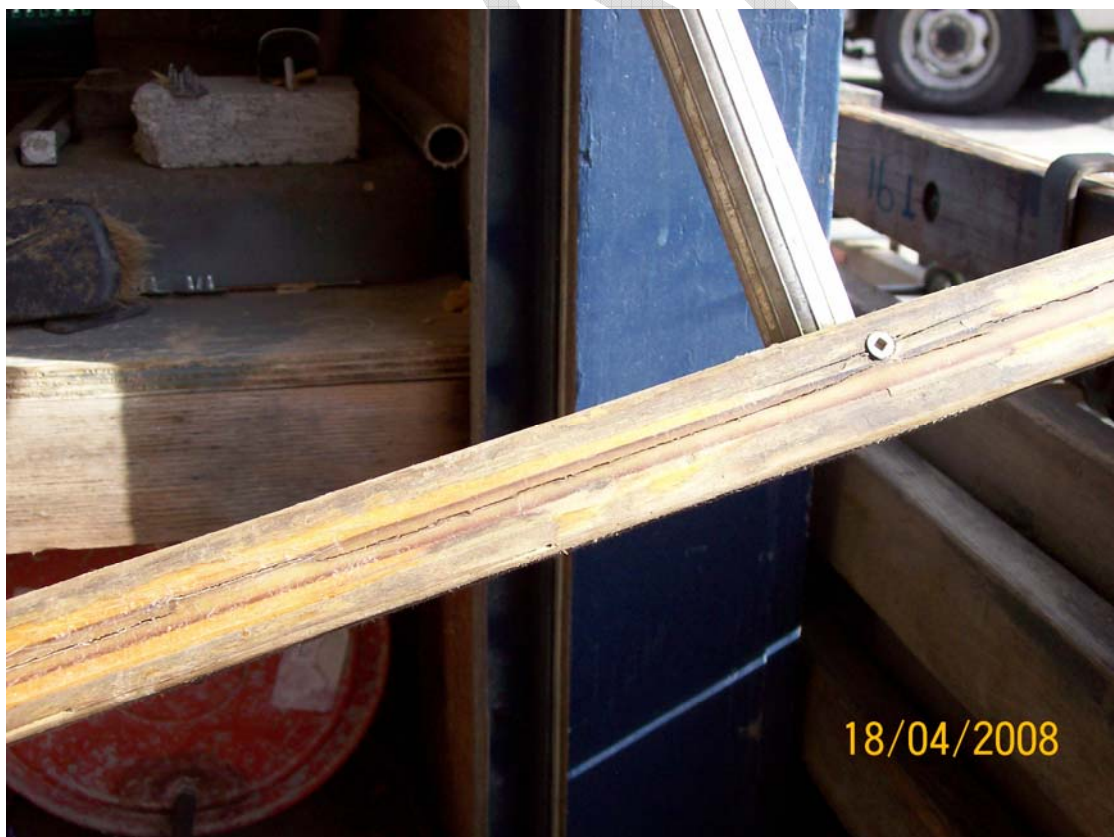
See photos below.

An extended ladder erected according to standard practice against a pole broke under the weight of a well-built line man. The ladder was wood-type, reinforced by fibreglass rods sealed in resin-covered groove recess in each leg. The ladder was subject to a regular inspection regime.

On investigation it appears that the resin had cracked in places and that this appears to have allowed the rod to slip along its length, reducing its ability to reinforce. It is understood that a variety of ladder brands and models incorporate this type of design.

The employer withdrew all ladders of this type from use, pending the outcome of an investigation. Any further available information will be advised in due course.

Employers are advised to check for signs of resin degradation or failure in this type of ladder and to be particularly vigilant in the inspection and withdrawal from service of defective items.
