# *Safety Advice 10-2002 (NZ)*

## PHASE TO PHASE CONTACT INCIDENT

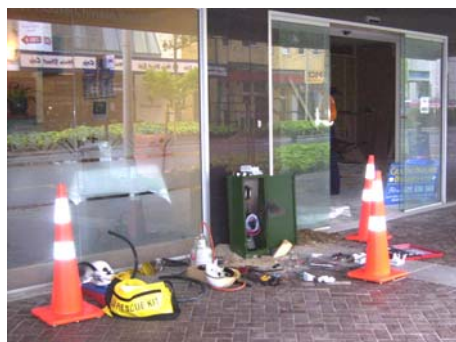
During this operation the bolt was difficult to locate and the lugs from the presumed red phase flicked across and made contact with the presumed yellow phase resulting in the phase to phase contact.

Due to little room between the phases at the 160amp Isolator and no means of physical barrier protection between phases to prevent phase to phase contact, the opportunity was allowed for the lugs on the presumed red phase to make contact with the presumed yellow phase.

- Once the scope of the job changed from that of terminating the cables to the de-energised side of the Isolator, work should have ceased and a re-evaluation of the new hazards conducted. Upon Inspection of the Isolator, it would have been evident that a major possibility or probability of phase to phase contact existed. Once the hazard was recognised, a control measure such as LV matting would have prevented this occurrence.

- Due to the lack of room and the closeness of the phases within the isolator, the correct type of tools to be used and having them available at the time would have assisted. The use of a small-insulated screwdriver upon reflection was not the best option to secure the slotted hexagonal bolt at the isolator.

1. A full face shield shall be worn when undertaking any work involving live LV pillars / pits.
2. Insulated tools shall be used when working on live LV pillars / pits.
3. Two operatives should perform all live work on pillars / pits.
4. LV rescue kit must be on site while live work is being performed.
5. Discussion with the manufacturer and distributor to explore the opportunity to redesign the 160amp Isolator to allow a physical separation between the phases.
6. All work on live equipment must be matted up as stated on the hazard I/D form NZ-HS-FORM-007.
7. In the event of the scope of work changing, all work must cease and a re-evaluation of the resultant risks undertaken and appropriate control measures put in place.
8. Work procedures revisited and any adjustments made to reflect best practice to be relayed back to the workforce concerned.
