Newsflash – 2019 01**14 January 2019 - Internal**

HV Cable Jointing Incident

On 10 January 2019 a third year apprentice acting as a mate to a jointer inadvertently damaged a live HV cable whilst working on an adjacent HV circuit. The damage caused a flashover within the joint hole which resulted in the jointer receiving a burn injury to his hand.

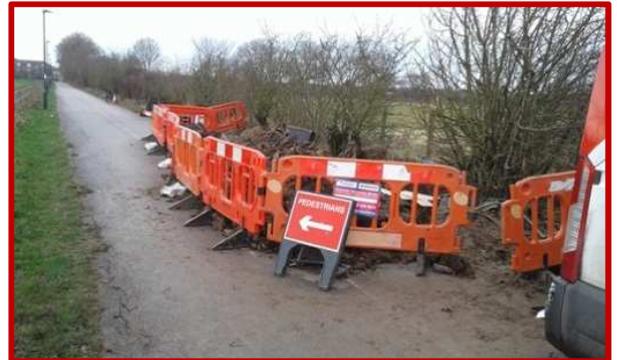
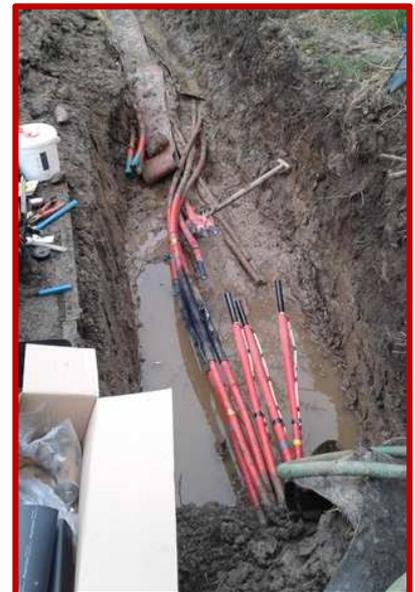
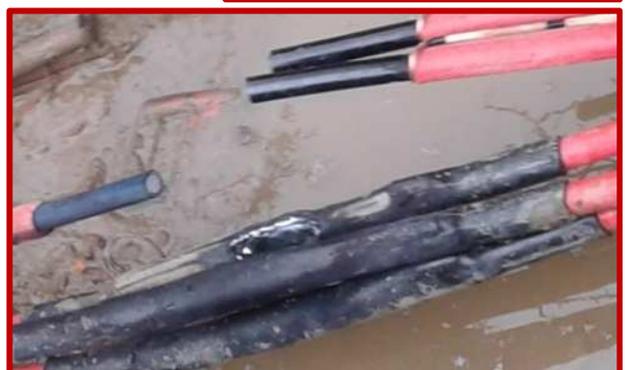
Initial indications are that the incident occurred whilst the jointer was cutting one core of the Triplex 11kV cable to the correct length for jointing using a battery operated reciprocating saw (Milwaukee Sawzall). As the saw came to the end of the cut the saw dropped and the blade cut into the insulation of an unprotected joint on the live 11kV triplex cable below, penetrating the insulation and causing a flashover to the live connector on the joint. The circuit protection operated and tripped the circuit out.

As a result of the flashover the jointer received burn injuries to his hand. Colleagues on site reacted immediately and applied a burns dressing pack. The jointer was taken to hospital by his supervisor where the burn injury was assessed. Fortunately injuries are confined to a blistered hand.

Specifically, the use reciprocating saws of any variety for jointing work is prohibited until further notice. Other approved and trained methods of cutting must be used.
