For issue to Scottish and Southern Electricity Networks (Employees and Contract Partners)

# SHE COMMUNICATION

## Potentially dangerous lighting columns...

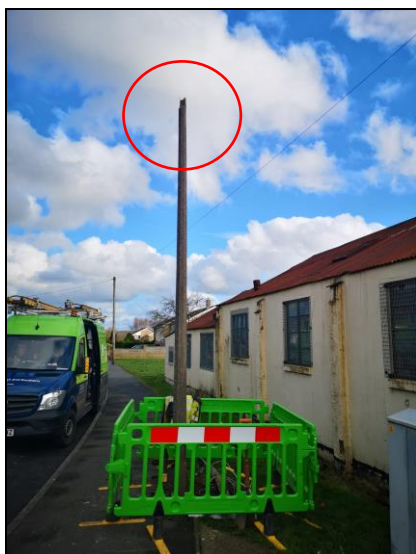
Our colleagues were not in contact with the column at the time of the incident, they were however excavating close to the column and it is believed that vibrations through the ground and into the lighting column potentially caused a latent defect to worsen and the column failed. The photographs below show the point of failure.

Chunk of failed concrete from lighting column caused the top extension arm to fall to ground

- d) All persons that work near lighting columns of this type are encouraged to take action and confirm, so far as reasonably practicable, the integrity of any respective lighting columns before starting work

- e) All persons that work near lighting columns of this type are encouraged to employ suitable and sufficient controls to help avoid danger to persons, e.g. pre-work assessments, exclusion zones, protective equipment, etc

- f) All owners of lighting columns of this type are encouraged to consider the details of this incident and take appropriate action to ensure all lighting columns of this type are fit for purpose and as such help to avoid recurrence of this incident, or similar

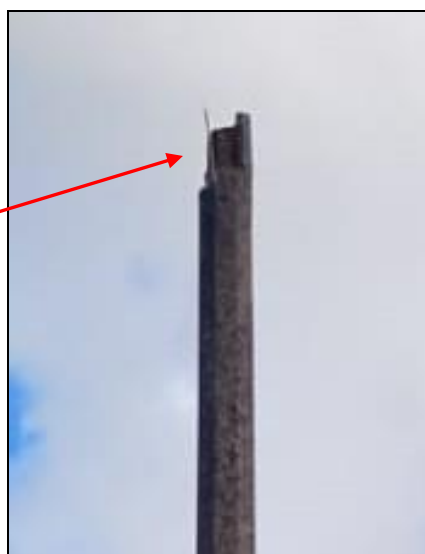
Top extension arm which fell to the ground

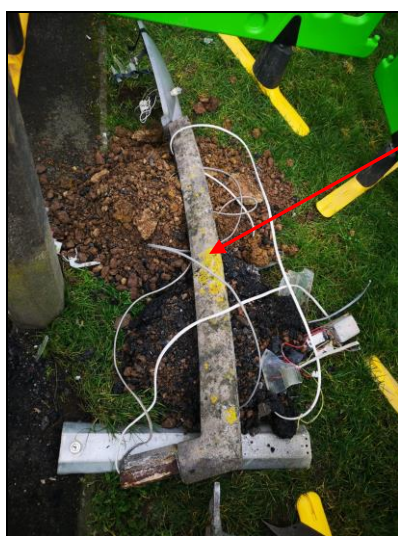
Chunk of failed concrete surrounding installation/fixing tube of top extension arm
