Newsflash - 2019 03 - Internal**20 February 2019**

LPG Storage and Transportation

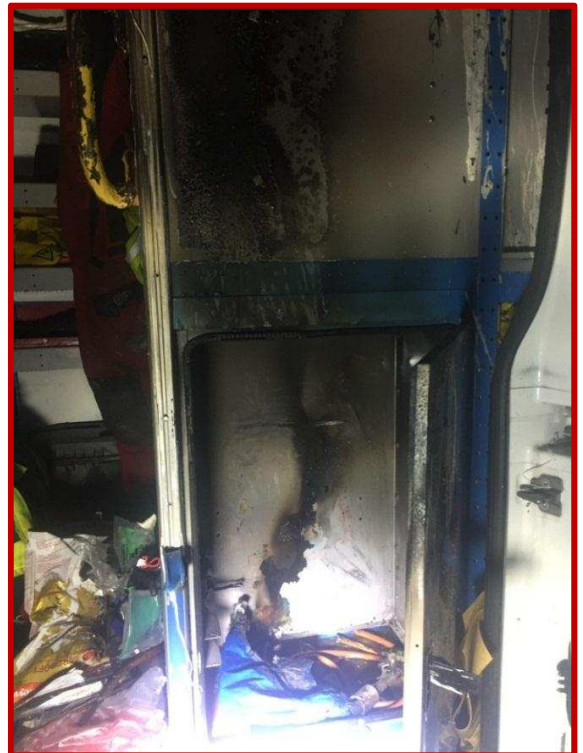
A recent incident resulted in fire damage to the Liquid Petroleum Gas (LPG) storage compartment on a jointer's Transit van. The fire which developed after the jointer had completed work, returned home and parked his van, was spotted by a neighbour who raised the alarm. The fire was extinguished by the jointer prior to the Fire Service arriving on site.

The Fire Officer confirmed the source of the ignition to be inside the gas compartment, most likely as a result of stowing a hot gas torch next to flammable materials in the form of plastic bags which had been stored inappropriately.

The fire was spotted and quickly dealt with but this could easily have ignited other items within the rear of the vehicle resulting in a more significant fire endangering people and property.

- Only LPG is stored in the cabinets provided.
- All valves shall be fully closed and regulators disconnected from gas bottles.
- Torches shall be allowed to cool off sufficiently before being safely stored.
- Bottles shall be secured in an upright position using the fasteners provided.
- Vehicles carrying LPG must be fitted with a suitable dry powder fire extinguisher of a least 2kg capacity.
- No additional materials shall be stored inside the gas compartment and any such items currently stored there MUST be removed immediately.

Operatives must follow their training on the correct storage and handling of LPG equipment and be trained in the correct use of the extinguishers provided.
