SAFETY**ScottishPowerExpress****HEALTH & SAFETY MATTERS**

Reference no: 251-04-2019

Title: Exposed Live Terminals

Exposed Live and Neutral Terminals & Conductors

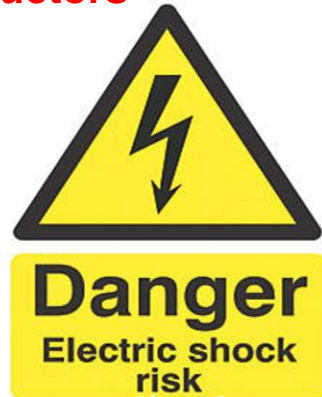
These types of incidents are easily averted with the use of Bungs, Insulating Putty, Shrouding and the correct termination of metering equipment cables. The following pictures show some recent findings detailing (1) exposed conductor, (2, 3) exposed terminal ports and (4) broken cut out fuse carrier.

- If you have any doubts about your processes or competence, **STOP WORK** and seek support from team leader/line manager.
- As the last responsible person having been on-site, you have a responsibility under the Health and Safety at Work etc. Act 1974 to leave the installation safe.
- All unused ports/terminals **must** be shrouded using your company approved equipment.
- All damaged DNO equipment **must** be reported using the appropriate MOCOPA Asset Condition Code process and adhering to your company's policy and procedures.
- All metering tails **must** be correctly terminated into all equipment (meter, marshalling blocks, time switch etc.) as per the manufacturer's instructions with **no** exposed conductors.
- Always carry out your final checks before leaving site.
