SHE COMMUNICATION

Are your trailer wheels secure?

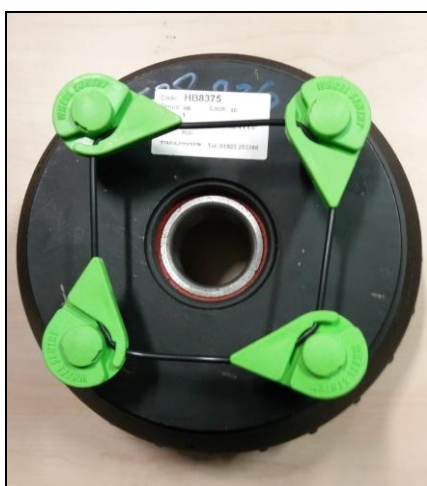
Image 1

Recently we have experienced several incidents involving trailer wheels working loose or becoming detached whilst in transit. Each incident was different but one common finding is that the current type of wheel stud retention device fitted to most of our trailers is not always effective. Because of this we have decided to introduce a different retention clip which has been proven to better secure wheel fixings and help prevent wheels coming loose.

- Our current choice of wheel fixing retention clip is shown in **Image 1** below.
- Our new choice of trailer wheel retention clip is shown in **Image 2** below.
- **Image 3** below shows our new retention clips in situ on a four-stud arrangement.

- Existing pre-use checks on trailers fitted with old wheel fixing retention devices (ref **Image 1**) should be completed until such time that all trailers are fitted with the new retention clips.

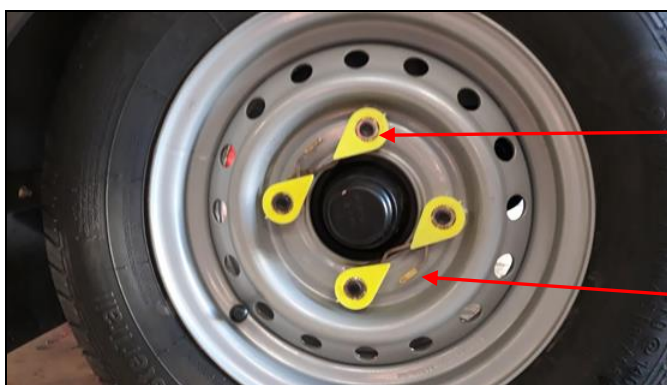
Image 4

- 1) Pre-use trailer checks on trailers fitted with the new retaining clips should determine whether the wheel fixing clips and associated indicators are fitted in accordance with the images provided below:
 - **Image 4** – complete four-stud arrangement with two clips and four indicators fitted.
 - **Image 5** – incomplete five-stud arrangement (partly fitted) showing two yellow position indicators fitted to one stud, and two new clips fitted to the remaining four studs.
 - **Image 6** – complete five-stud arrangements with two clips and six indicators fitted.
- 2) When completing pre-use trailer checks, our existing 'Vehicle Check and Defect Book' should be used to record conclusions.
- 3) Trailers with defects identified should not be used; all defects must be reported to your Manager/ Supervisor and the SSE Fleet Team.
