## Schneider / Merlin Gerin ACB LV Board Failure

On 25<sup>th</sup> July 2019 a Schneider / Merlin Gerin Air Circuit Breaker (ACB) on a shielded-type wall-mounted LV Board disruptively failed at Whitby Grammar School substation in Ellesmere Port shortly after being operated. The ACB forms part of a “Type X” unit protected arrangement used predominately in SPM.

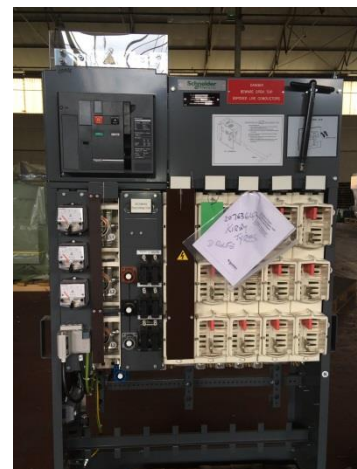
Figure 1: Schneider Shielded LV Board

The photographs opposite show the type of equipment involved. Photographs shown are typical examples of Schneider shielded LV boards with an ACB.

- In line with operational procedures on entering the substation the Operator shall carry out a visual inspection of the LV board to check for any signs of distress. Should any signs of distress be noticed, then the substation shall be evacuated immediately and OCC/NMC shall be informed.
- Prior to any operation of any LV ACB (regardless of manufacturer/model) the Operator shall notify OCC/NMC.
- All LV ACBs (regardless of manufacturer/model) which form part of a shielded LV wall-mounted board shall not be operated live.
- Note: LV ACBs on unshielded type LV boards are not affected by this restriction.
