Update: Use of High Voltage Indicators for Testing or Phasing Checks

This is an update to Express [EXP-10-412](#) which was issued in July 2017 after an incident in which a member of staff received significant injuries whilst carrying out live phasing checks across the busbar and feeder spouts on a Hawker Siddeley Hawkgas Type HG12 11kV switchgear panel using a moving coil voltage indicator. SOP 407 was applied in SPEN as a precaution after the incident.

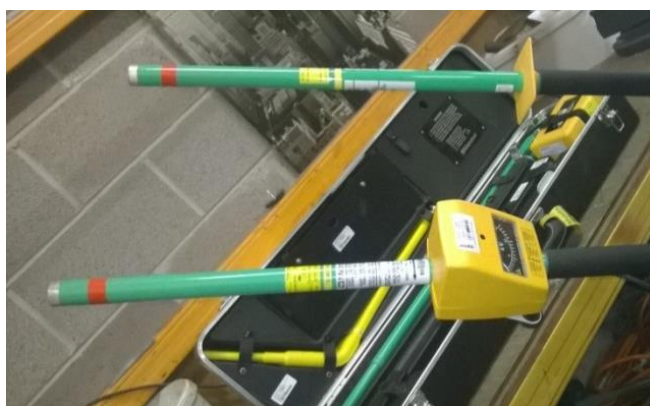
The independent expert investigation of the HV Voltage Indicator and Phasing Rod also identified no defects and ruled out this equipment as a contributing factor to the incident.

Moving coil type HV Voltage Indicator and Phasing Rod

- Additionally, [OPSAF-12-005 \(LWM 2.3\)](#) which covers the use of Approved HV Voltage Indicators and phasing-out devices, has also been updated. This procedure now requires that when proving not live or phasing-out on spouts of withdrawable switchgear, Approved bent-end adapters shall be used on vertically withdrawable 11kV switchgear and bent end adapters/extension pieces shall, where reasonably practicable, be used on all other withdrawable switchgear. The HV Voltage Indicator shall be dismantled and the probes, extension pieces and bent-end adapters shall be cleaned using the cleaning kit supplied with the instrument.

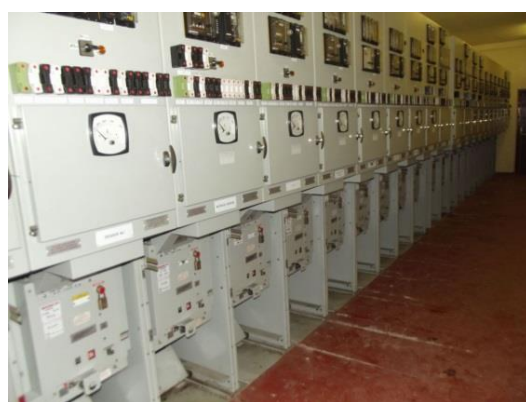
Investigation of the HG12 switchgear confirmed that a flashover and power arc occurred between the fixed contact in the spout and the earthed metal components at the bottom of the spout. Examination of the moving portion of the circuit-breaker revealed evidence that a low-energy flashover had occurred on the circuit-breaker isolating bushings/spouts at some time previously. Inspections of other HG12 fixed portions and moving portions within SPEN has not revealed any signs of similar degradation.

It has been concluded that the cause of the flashover is not attributable to any Type defect of HG12 switchgear involved in the incident.

Hawkgas HG12 11 kV switchgear

- [OPSAF-12-004 \(LWM 2.2\)](#), which covers operation of the HV AC system up to and including 33kV, has been updated to define the different acceptable techniques for carrying out phasing checks after completion of work on the HV System. Checking across the Live busbar and feeder spouts using an Approved HV Voltage Indicator is only permitted where none of the other described methods in OPSAF-12-004 are reasonably practicable.

- OPSAF-12-005 now also requires that before inserting any test instrument into switchgear spouts, the circuit-breaker moving portion and spouts shall, where practicable, be inspected for evidence of distress to the bushings and contacts such as burning, arcing or soot deposits. The necessary PPE that shall be worn when carrying out these tests is detailed in section 10.2.3 of OPSAF-12-005 and comprises FR coveralls (fastened to the ankles, wrists and neck), Approved rubber gloves and full face visor or helmet with integral visor.
