SAFETY BULLETIN SB3/2019 (TBX - 97)

Failure of Klauke Mini Insulated Crimping Tool

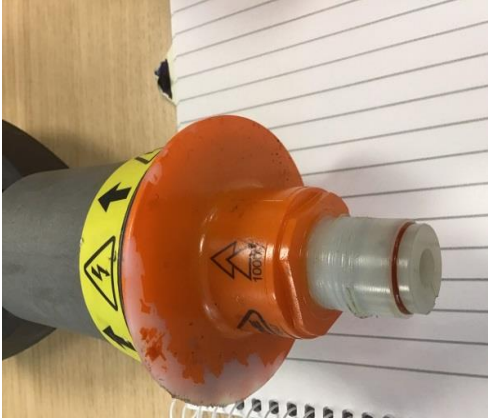
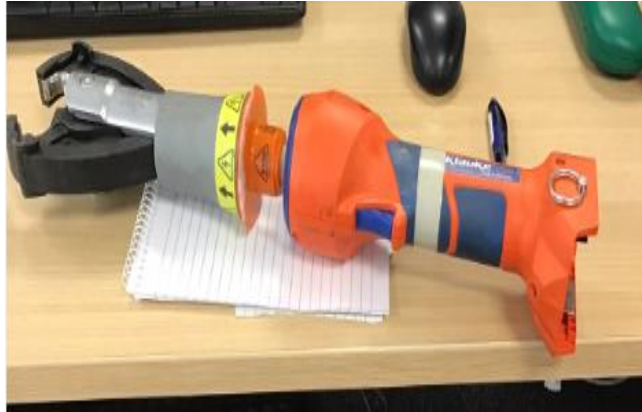
A Klauke insulated mini crimping tool failed, which resulted in the head of the device being ejected from the body of the device, narrowly missing the face of the operator.

A Klauke insulated mini crimping tool was being used to crimp an overhead line non-tension connector. While under compression the head of the tool separated from the body of the tool. The head was ejected from the tool with force landing a distance away from the operator. Hydraulic oil was also ejected from the body of the tool onto the operator.

Immediate examination of the tool revealed the plastic threads connecting the head of the tool were sheared. The tool has completed 189 operations and was not due for service until 5000 operations had been completed. It was returned to the manufacturers for an urgent investigation into the cause of failure and the manufacturers have identified that all tools of this type shall be recalled.

- Managers to ensure that all Klauke Orange Line Fully Insulated battery crimping and compression tools shall be withdrawn from service by Friday 27th September.
- Managers should record the details of these tools and arrange collection of them by Horizon.
- The manufacturer shall then inspected and either return or replace the tools.
- (Ideally returns should be co-ordinated by one point of contact at each Depot)
- Staff to be reminded of the importance of wearing safety glasses/visor whenever they carry out work; in this case they prevented hydraulic oil from entering the operator's eyes.
