**Newsflash - 2018 11****31<sup>st</sup> July 2018 - Internal**

## Earthing theft from Distribution substations

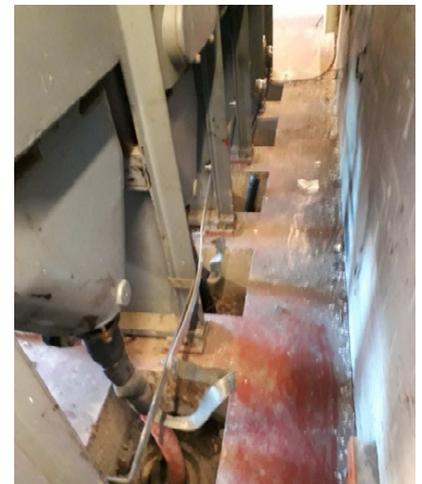
Picture of repaired Reyrolle C gear earthing post theft

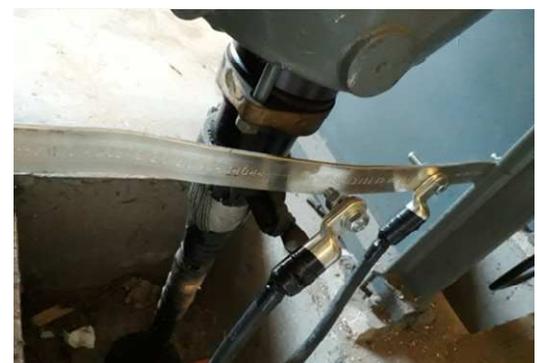
Earthing repair to Reyrolle C gear post theft
