Document No:	HSS 406 OA 12	Issue Date:	30 November 2018
Type:	Operational Safety Alert		
Subject:	Operation of Early EMMCo TMC Hinged Transformer Links		
Applicable Areas:	EPN / LPN / SPN / Services	Applicable Job Roles:	All Operational Staff
Issued By:	Asset Management	Author:	Daniel Elphick
Circulation:			
<input type="checkbox"/> All UK Power Networks Staff <input checked="" type="checkbox"/> Asset Management <input checked="" type="checkbox"/> Capital Programme & Procurement <input checked="" type="checkbox"/> Connections <input checked="" type="checkbox"/> Contractors <input type="checkbox"/> Customer Services <input type="checkbox"/> Finance <input type="checkbox"/> G81 External website <input type="checkbox"/> HR & Communications <input checked="" type="checkbox"/> ICPs (Independent Connection Providers) <input checked="" type="checkbox"/> IDNOs (Independent Distribution Network Operators) <input type="checkbox"/> Information Systems <input checked="" type="checkbox"/> Legal <input type="checkbox"/> Meter Operators		<input type="checkbox"/> Network Operations <input checked="" type="checkbox"/> EPN <input checked="" type="checkbox"/> LPN <input checked="" type="checkbox"/> S

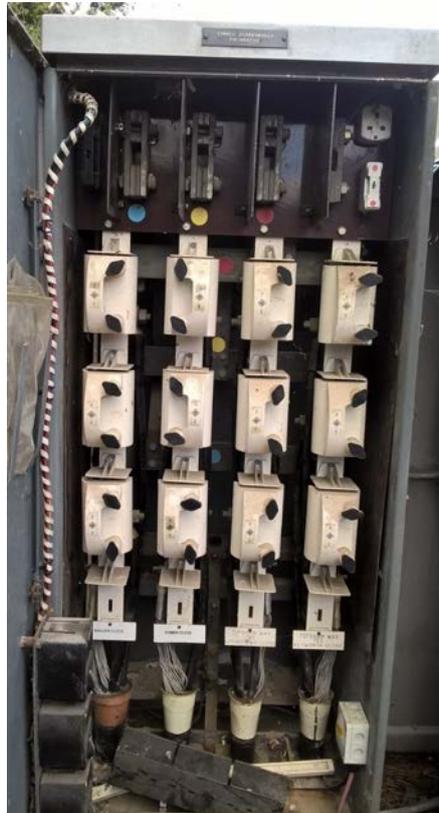
Transformer Mounted Cabinet showing Transformer links at top

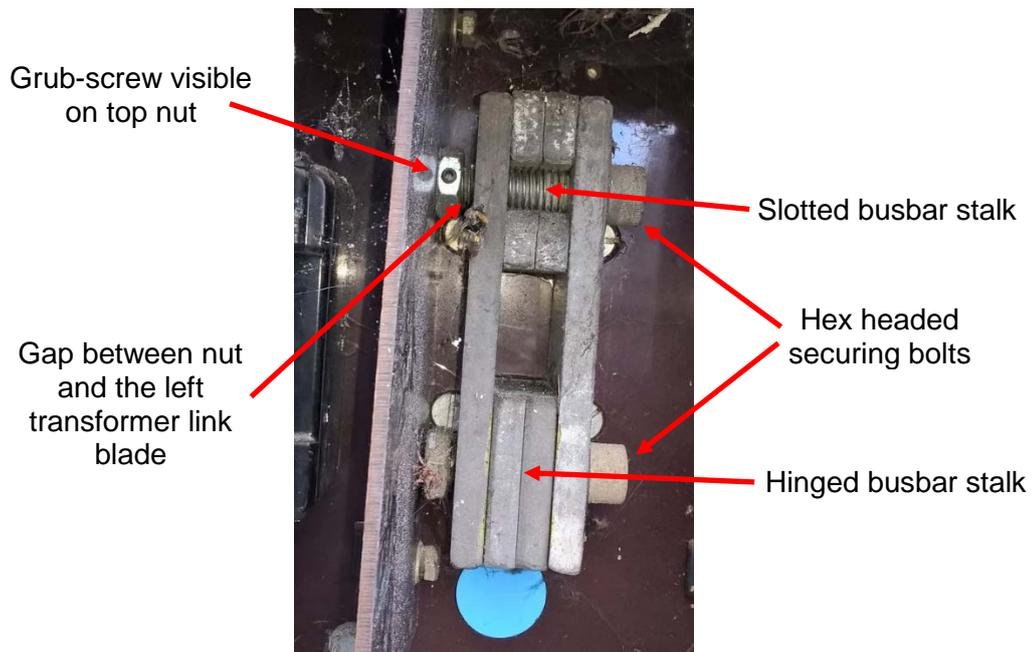
Each transformer link consist of a two bladed tinned copper solid link with two securing bolts, with the bottom one forming a hinge.

The investigation has concluded the nut on the left hand side of the left hand blade is only there to prevent the hex headed bolt, from being undone too far, or fully, when the link is loosened. The grub screw in the nut prevents it being undone from the bolt.

The hex headed bolt tightens into the left hand blade, which is threaded, this tightens the left and right hand moving blades onto the fixed stalks.

It is not required to use a spanner to hold the nut on the left hand side of the blades. This nut does not affect the tightening or loosening of the link.

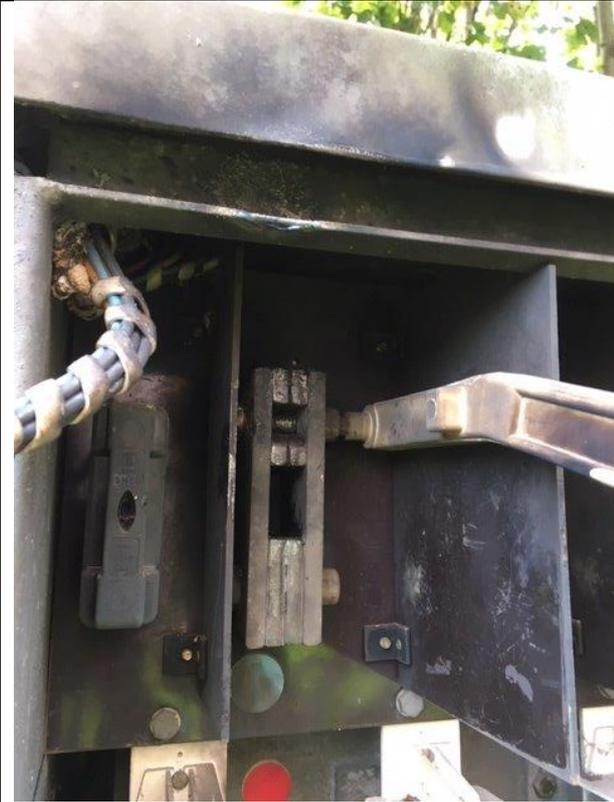
Transformer Mounted Cabinet showing the insulated tool used to tighten the hex socket headed transformer link bolt.

This type of link with a hex socket headed bolt shall only be tightened and loosened, using the approved insulated tool, provided for this purpose and when both bolts are loose.

Only this approved insulated tool shall be used to tighten, insert or to remove this type of link. **No other tools are required.**

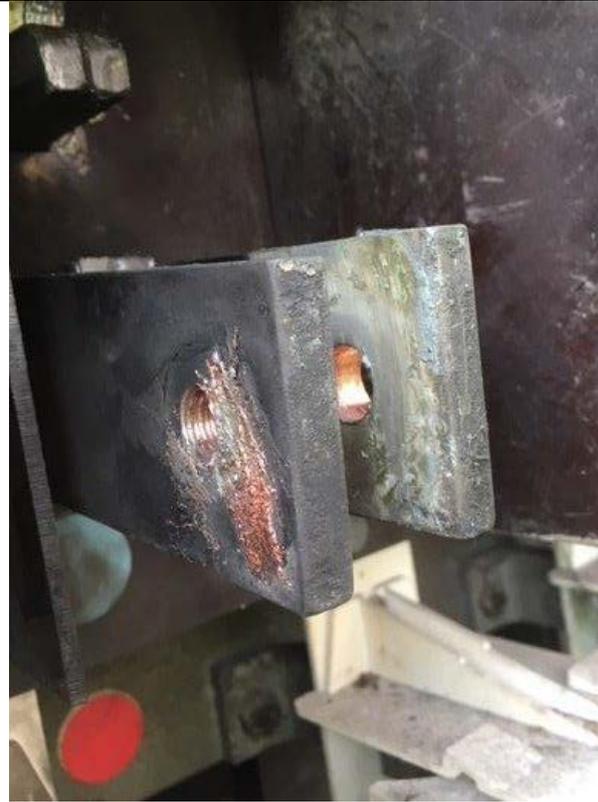
Transformer link with the hex socket headed transformer link bolt and nut removed to show the threaded inside of the left hand blade.
