Safety Bulletin No. 08/2016

LIFTING OF WOOD POLES – STAY WIRES

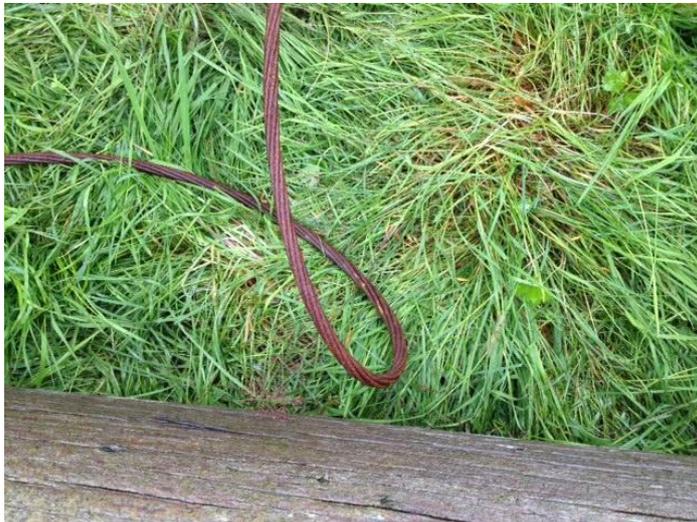
The cause of the pole falling was a loose stay wire that was still attached to the pole catching and releasing the spring loaded safety catch on the grab hook. As the pole was then being moved the chain holding the pole came out of the grab hook resulting in the pole falling.

Lose stay wire attached to pole

- When lifting and moving poles using grab hooks any stay wires should be removed or secured to the pole so they are not hanging loose.

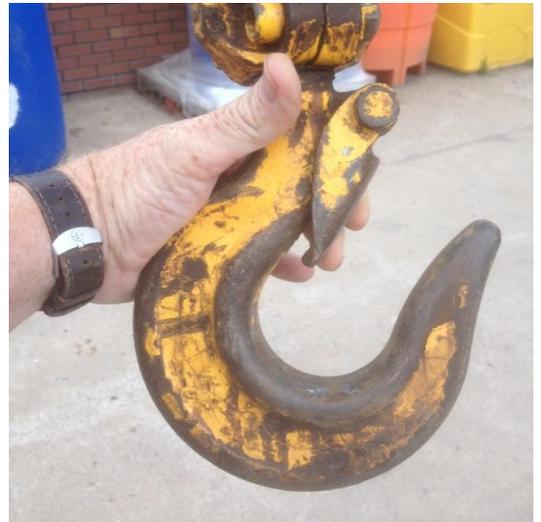
Grab hook with spring loaded safety gate
