# Fibreglass Universal Adapter

## Background

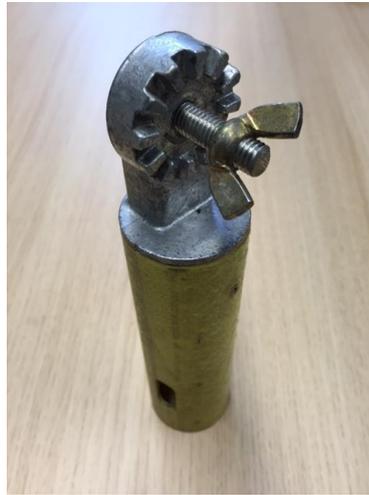
Fig. 1 Fibreglass Universal Adaptor

There have been two recent incidents involving fibreglass universal adaptors failing. This adaptor is used with operating rods for coupling operating tools such as the Loadbuster.

- Discontinue the use of Fibreglass Universal Adaptors with the Loadbuster Tool, Fusecup and LV Fuse Combination Unit Adaptor immediately
- The Aluminium Universal Adaptor (ESB Code 8817152) shall be used with the:
  - Loadbuster Tool
  - Fusecup
  - LV Fuse Combination Unit Adaptor
- Fibreglass universal adaptors can continue to be used with voltage detectors provided they are inspected by the User before use and are in good condition with no signs of cracks or damage.
- All fibreglass operating heads such as Bayonet Adaptors for application of earths shall be inspected by the User before use.
- Any defective adaptors shall be tagged and put beyond use.

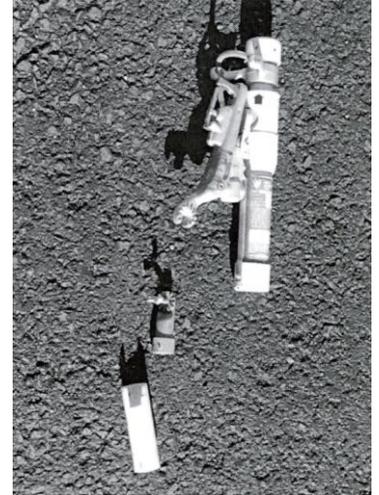
Fig. 2 Loadbuster Incident

In the second incident the metal insert broke away from the universal adaptor under the weight of the Loadbuster Tool. (Fig. 2)

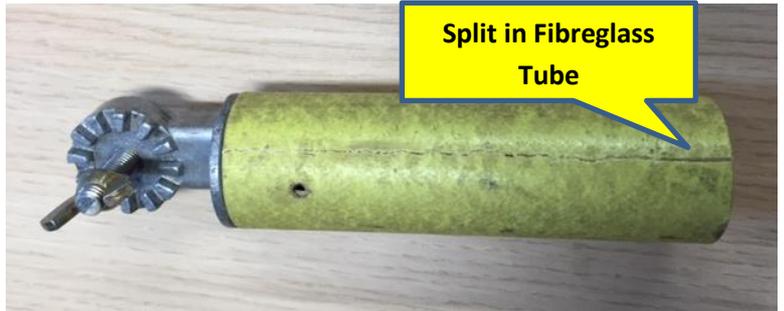
Fig. 3 Fibreglass Universal Adaptor with Split In Fibreglass Tube

In the first incident the fibreglass universal adaptor split while the NT was operating S&C links causing the operating rods to come away. (Fig 3)
