## Sandstone Pillar Collapses onto Footpath

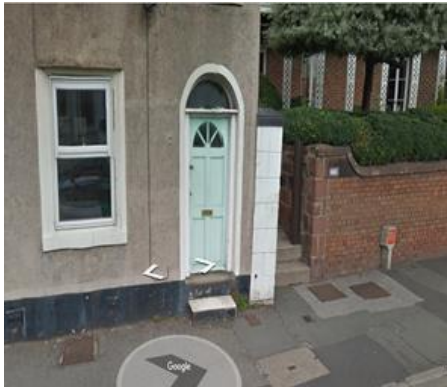
*Pillar [Google Maps]*

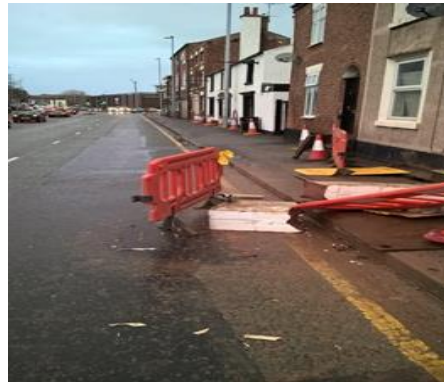
*Pillar after the Incident*

The next day, SPEN jointers arrived on site to find that a large sandstone pillar had collapsed across the excavation, with the top section lying on the edge of the carriageway.

The initial findings from this investigation have highlighted that this structure (pillar) was a free standing pillar and it was not tied or keyed into the adjacent property or garden wall.

- **Ensure you understand the risks associated with the work activity.** Many garden or boundary walls have very shallow foundations, which can be affected by vibration from work equipment such as jack hammers and mechanical excavators.
- **Assess and control the risks.** Never begin any excavation if your START assessment highlights that a wall or structure could become a hazard.
- **Think before you act.** Continually monitor your working environment and surroundings for new risks. Look out for each other and work as a team.
- **Only undertake work you are competent to do.** If shoring is required, then it must be erected by competent and trained operatives.
