Safety Bulletin No. 09/2017

INDOOR SUBSTATIONS – FALL OF FACIA STONE

Issue date	27 July 2017
Issued by	Vincent Cranny, Head of Health, Safety & Environment
Applicable to	Operational Employees

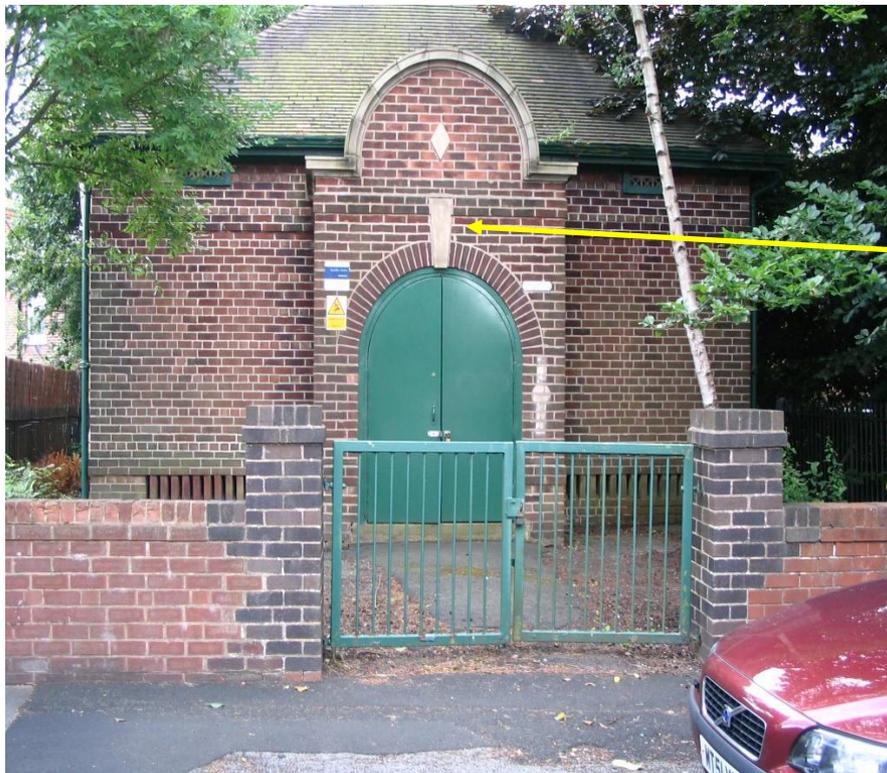
Initial investigations have concluded that the facia stone was not adequately secured when the substation was originally built (c1950s), the facia stone has a lip which sits over the door frame, the door frame itself has become loose over time and the door lock hasp has become stuck. It is thought that whenever the substation door has been opened and closed the door frame has moved and gradually loosened the facia stone.

Facia Stone in place

Although there is no specific procedure for checking the integrity of the fabric of substation buildings when entering, and no indication that a check would have identified the risk with this facia stone, **good practice when entering any indoor substation building is to visually check the building for any obvious signs of damage or deterioration that presents a risk.**

Such a check can be part of the dynamic risk assessment alongside the formal substation entry procedure prescribed in Code of Practice 606 procedure S.28. Any defects relating to building structure should be reported to the Civil section for rectification.

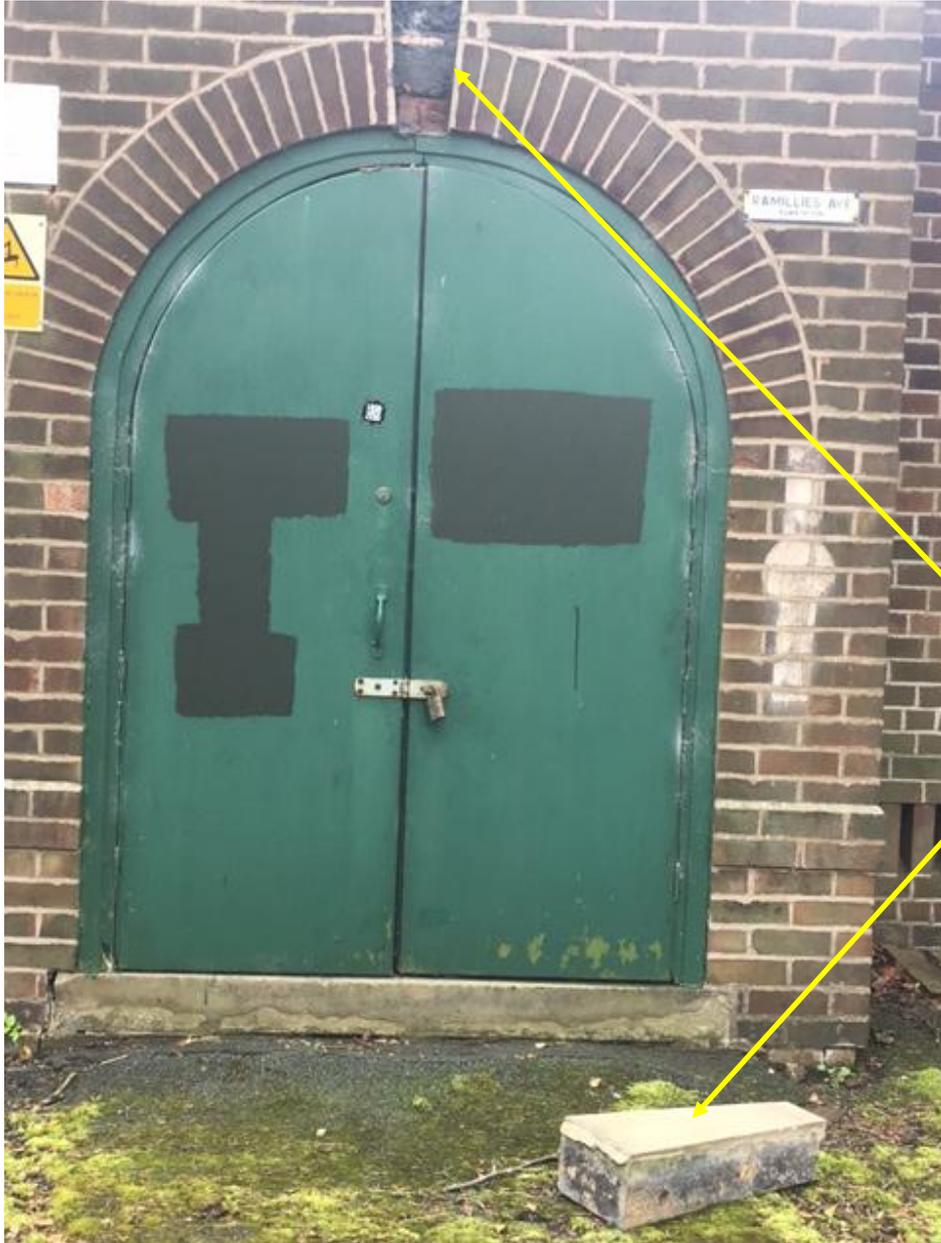
As the substation door was being unlocked a large facia stone fell from above the door striking the Fault Technician on the head resulting in a large cut that required medical treatment.

Fallen Facia Stone
