Safety around excavations

An accident occurred on 23 July 2017 that involved a jointer suffering a serious ankle injury when the side of an excavation collapsed whilst he was rearranging the signing and guarding. As the side of the trench collapsed the jointer fell into the 1 metre deep excavation and twisted his ankle as he landed. The jointer attended hospital for an X-ray where it was confirmed his ankle injury was limited to a sprain rather than a suspected fracture. Nevertheless he will require several weeks of convalescence before he is fit to return to work.

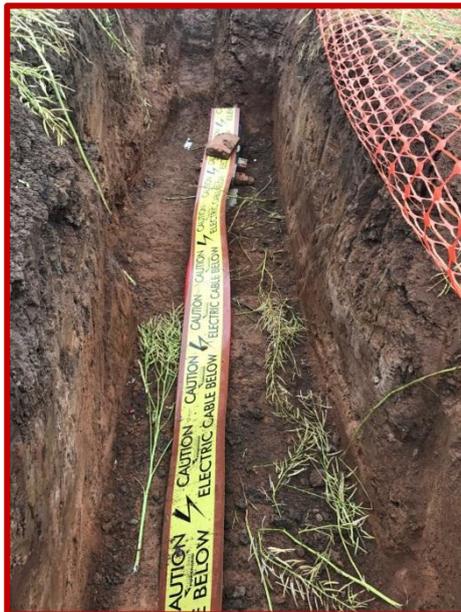
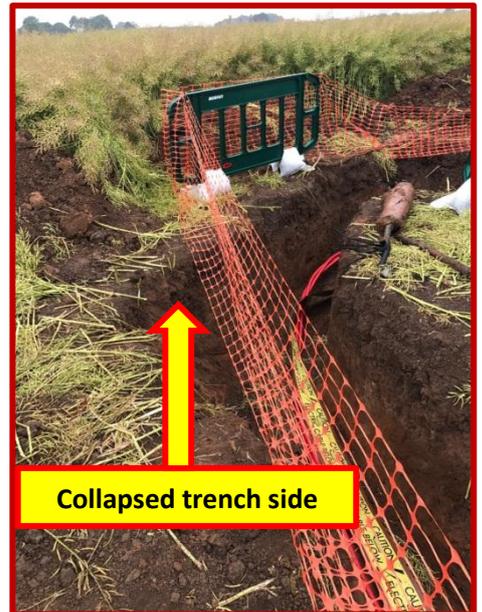
As you can see from the pictures, the excavated joint hole and trench is in a field of crops and Chapter 8 signing and guarding was not required. Plastic mesh fencing was used to guard the excavation.

The trench was excavated using a mechanical excavator which resulted in the soft clay soil having straight trench sides. The guarding was placed close to the trench side.

Excavations are a daily feature of our work and the routine nature of the work can sometimes create an over familiarity with the hazards associated with work sites and, as a result, a feeling of safety in a hazardous environment. To ensure we create a safe working environment it is important that we do not become blind to, and accepting of, potential work site hazards and that we risk assess the work site, both at the start of the work, as the work progresses and when the conditions change. The stability of the ground and structures around excavations is something to be aware of at all times (joint holes and trenches). In this particular instance the hazard was not recognised as the sides of the joint hole appeared to have been stable.

Each route into and out of an excavation has a different set of hazards that need to be recognised and addressed to reduce the risk of a slip, trip and fall event. These should be risk assessed by all members of the team and the agreed safe route clearly communicated to all staff (including contractors) working on site.
