## Safety around Excavations

An accident occurred on 16 April 2016 involving a jointer's mate who suffered a knee injury when a flagstone at the side of the joint hole tipped under his weight, causing him to fall into the excavation. The mate was repositioning a battery lighting pack at the side of the joint hole for the jointer when the incident occurred. It was fortunate that the jointer, who was in the joint hole at the time, was able to react quickly and break his fall, otherwise the injuries could have been even more serious.

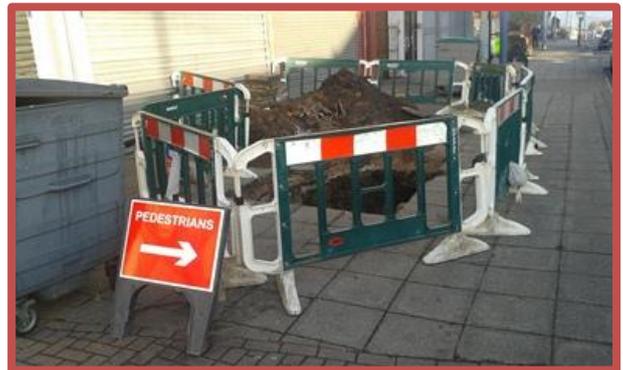
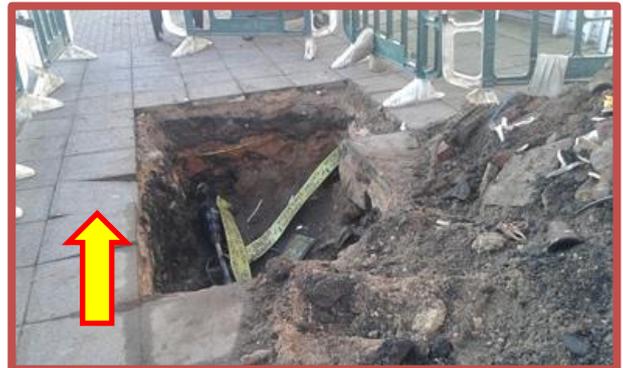
As you can see from the pictures, the excavated joint hole is to the correct standard in that the sides of the hole are clear from spoil. There is a clear access and egress route to the side of the joint hole and signing and guarding is all present. To all intents and purposes, this would be a copybook example of a joint hole excavation, yet we have still incurred a serious injury accident. The mate suffered a knee ligament injury that required hospital treatment and he will require several weeks of convalescence before he is fit to return to work.

The stability of the ground and structures around excavations is something to be aware of at all times (joint holes and trenches). In this particular instance the hazard was not obvious as the sides of the joint hole would appear to have been stable, especially as the excavation was in a flagged area. Tarmac excavations present an even greater risk of being undermined at the edges of the excavation.

To ensure we create a safe working environment it is important that we do not become blind / accepting of potential work site hazards and that we review and risk assess the work site, both at the start of the work and as the work progresses and conditions change.

Ensure the edges of the excavations are not undermined such that the top surface layer becomes load bearing to anyone working at the side of the excavation. Try to keep the same safe route into and out of the joint hole.
